Equipment Overview

Mine Safety and Health Administration

Today's Discussion

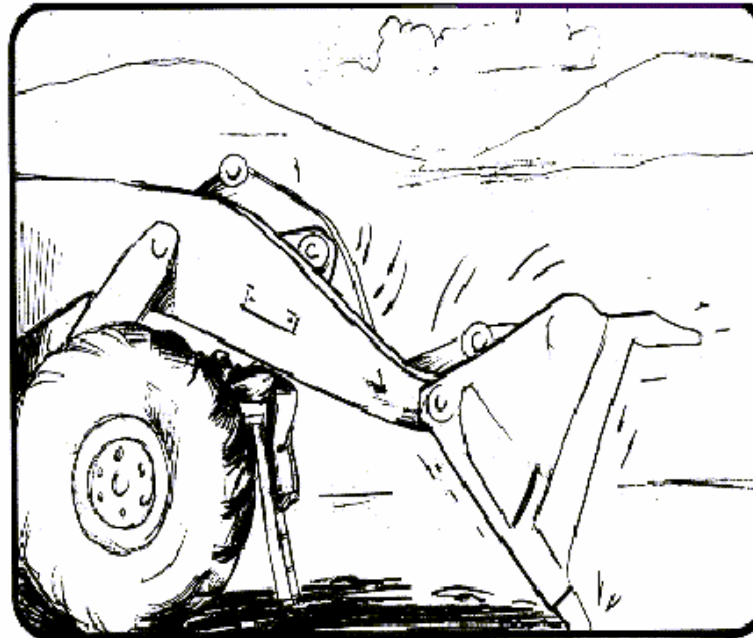
METAL/NONMETAL MINE FATALITY - On August 1, 1998, a 61-year old mechanic (contractor employee) with no mining experience was fatally injured at an alumina mill. The victim was performing maintenance on the hydraulic system of a front-end loader when a sudden release of hydraulic pressure caused the bucket support arm to fall, pinning him against the loader frame.

- Maintenance should not be performed unless the power is off and machinery components are blocked against hazardous motion.

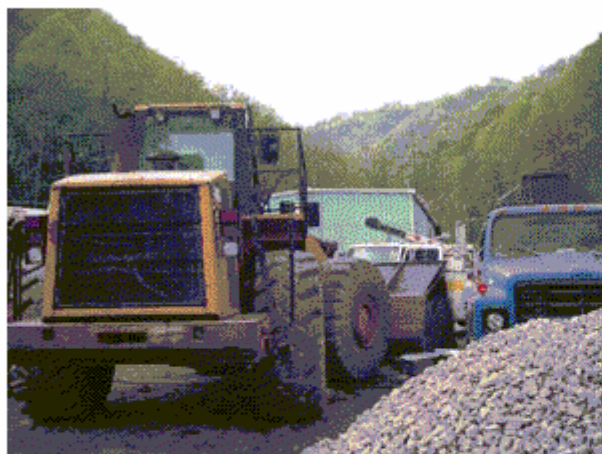
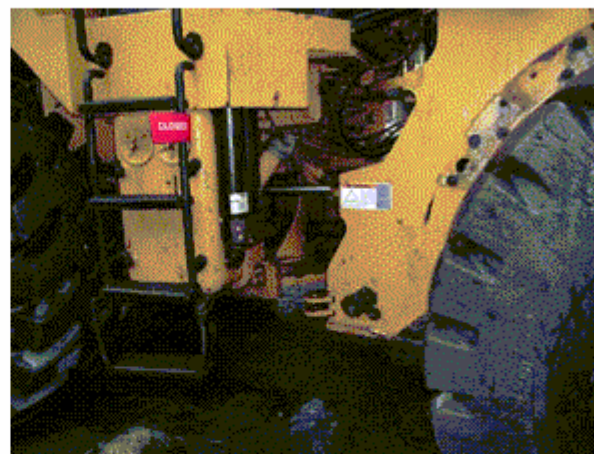
COAL MINE FATALITY - On Thursday, April 21, 2005, a 22-year old contractor employee (Field Service Technician), with 27 months total experience, was fatally injured while repairing a Caterpillar 980 G front-end loader. The victim was working in the articulation area of the front-end loader when it unexpectedly pivoted, crushing the victim within the pinch point.

- Never work or travel in the loader's articulation area without engaging the steering frame lock or without using another effective means of preventing motion if the lock cannot be used.
- Lower the bucket and shut-off the machine before performing maintenance.
- Follow the manufacturer's guidelines and recommended procedures for safe repair and maintenance of equipment.
- Observe and follow all warning labels and signs on equipment.
- Include safe procedures for repair and maintenance of equipment in training programs.

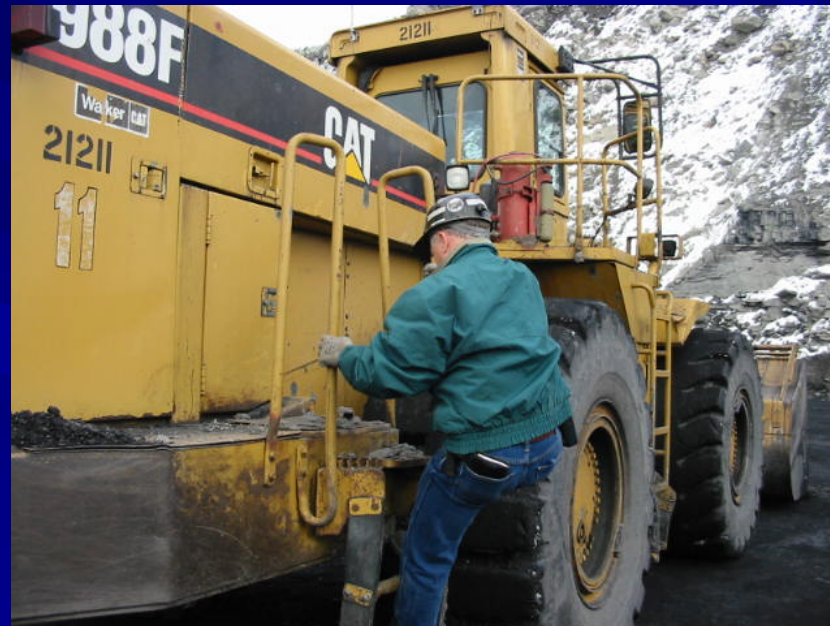
CAT Equipment Involved in Getting on/off Equipment Type Accidents (2001 – April 2006)

Top 10 Models #	# Acc.
980 G	41
988	31
988B	30
992	28
988F	27
992C	27
777	26
777B	23
785	22
980	21

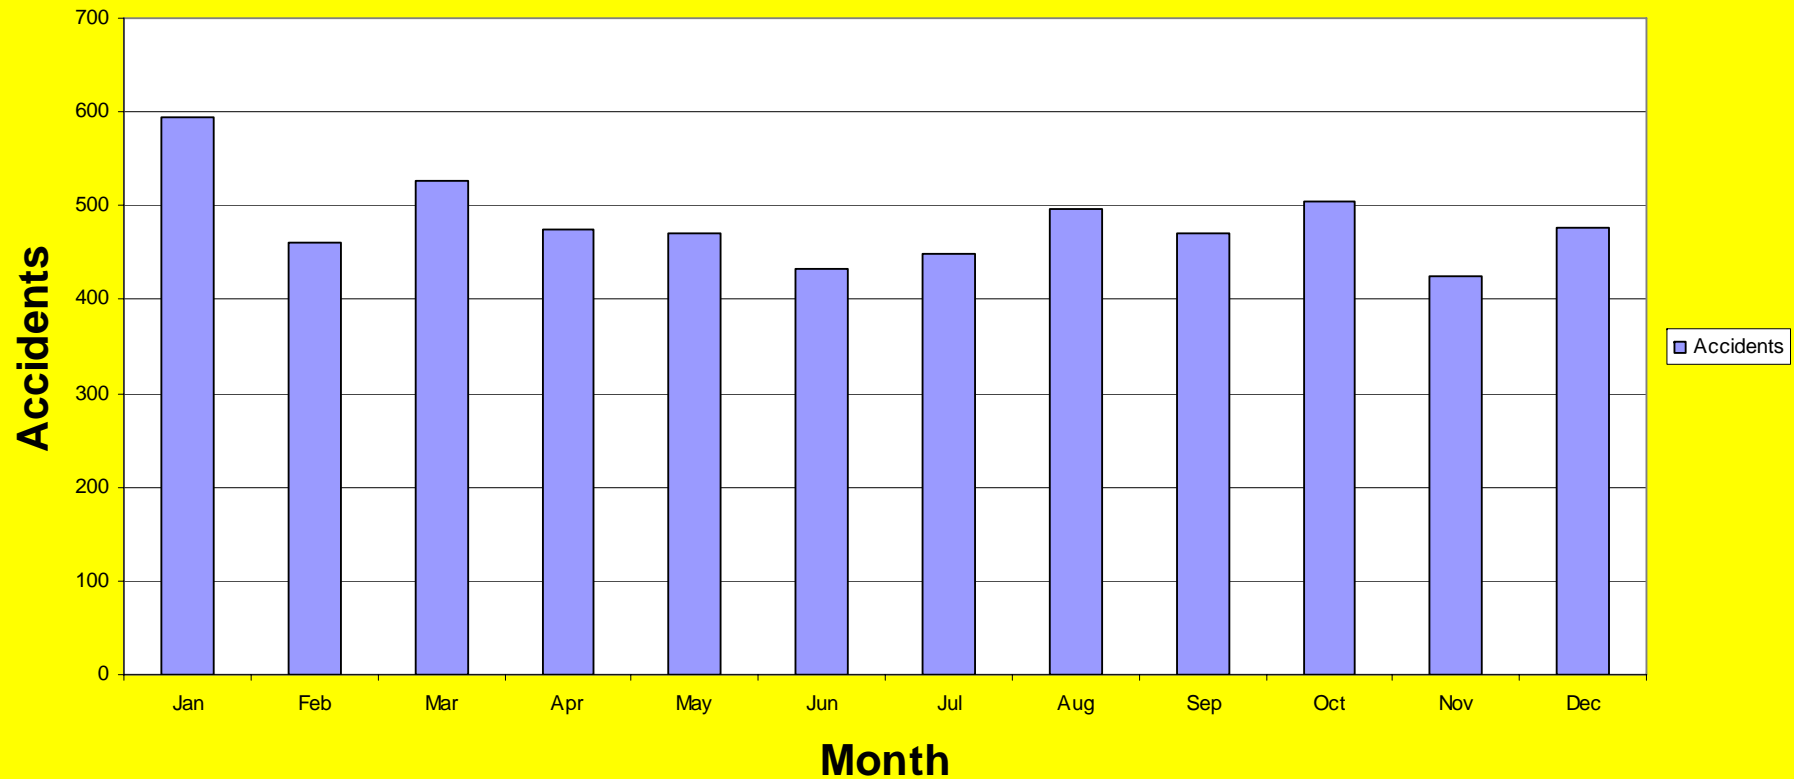
Ingress/Egress Accidents by Month

On / Off Equipment Injuries (2001 – April 2006)

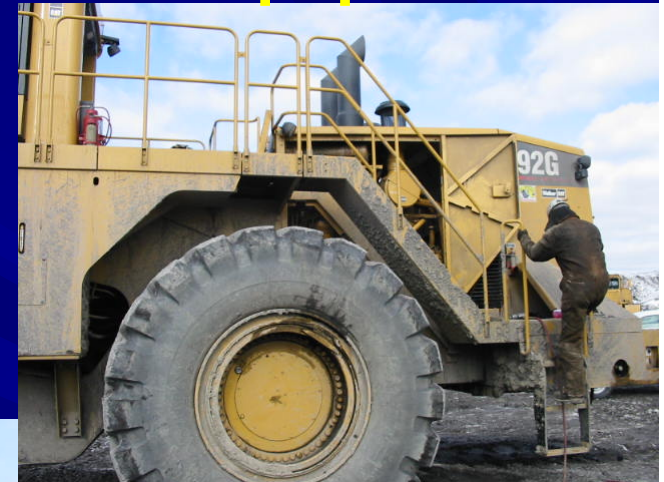
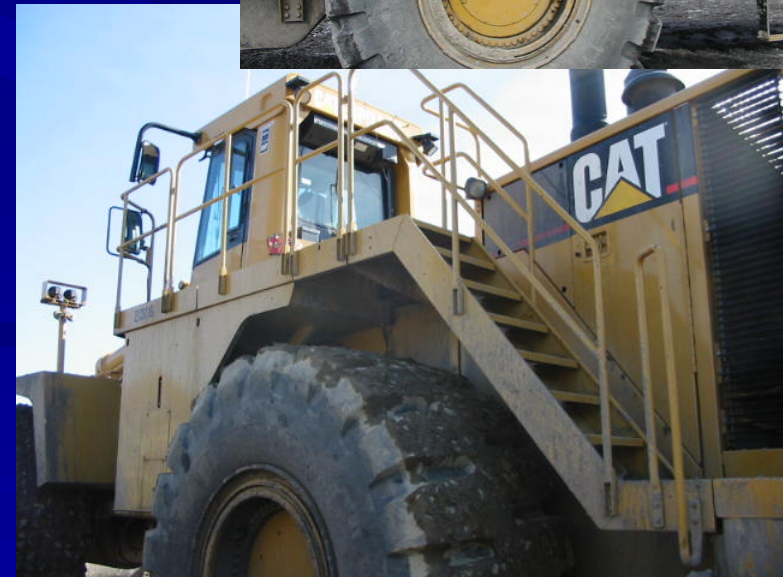
Can older equipment be retro-fitted with stairs to match newer equipment ?

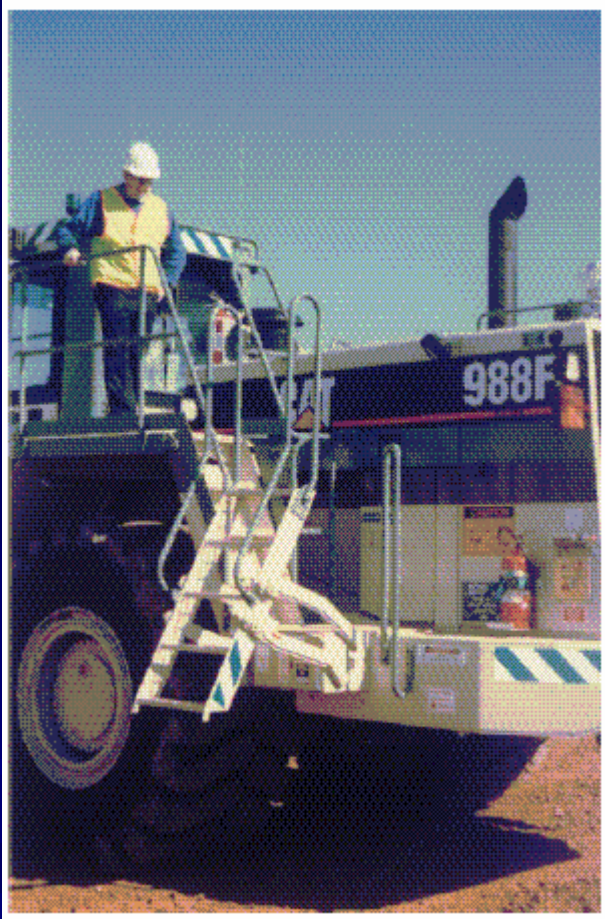
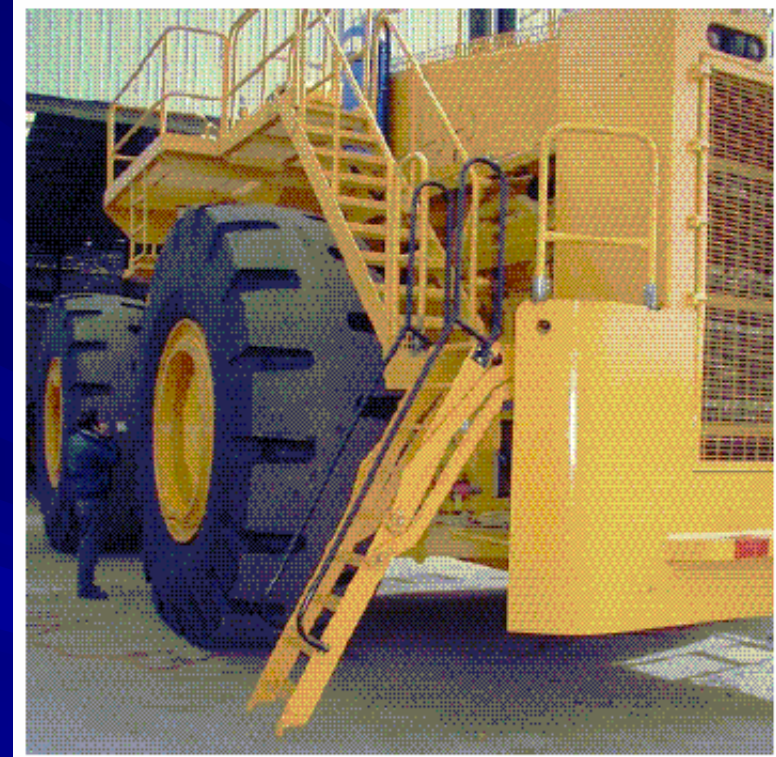
Potential Retro-Fitting Access Solutions??

Mining companies are concerned with liability and warranty issues if they change a manufacturer's design.
