BEST PRACTICELOCATION:QuarryARTICLE YEARACTIVITY:Manual handling and storageCOMPANY:SUB ACTIVITY:N/ACOMPANY LOCABEST PRACTICE No:BP311COMPANY TEL:COUNTRY OF ORIGIN:United Kingdom

ARTICLE YEAR2006COMPANY:Foster YeomanCOMPANY LOCATION:Glensanda Quarry, MorvernCOMPANY TEL:01631 730441

Installation of bulk propane gas storage system

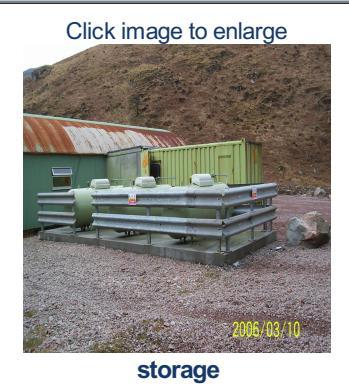
To remedy the situation, a new gas storage system, bringing all three tanks into one place, has been positioned in a sheltered location. A concrete pad forms the base and underground pipes link directly to the tumble dryers and the kitchen.

There are devices to measure the flow of gas, with a safety cut-off valve that can work if the flow of gas is too low, indicating a leak. The tanks are scheduled to be refilled when they drop to 25 per cent capacity, to ensure an uninterrupted supply.
