LOCATION: **Concrete products plant** ACTIVITY: SUB ACTIVITY: N/A BEST PRACTICE No: **BP326 COUNTRY OF ORIGIN: United Kingdom**

Paddle lock bars for the mixer

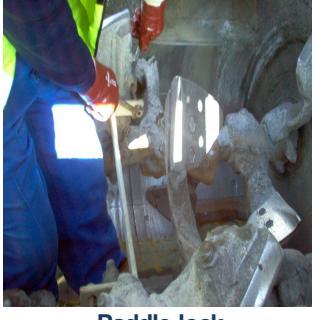
Paddle lock

The team at this site came up with a paddle lock to solve the problem. The bar was designed to fit over the paddle arms and be locked into place using bolts and tightened with the use of spanners. This meant that, in order for the paddles to become free again, a tool had to be used - they could not be set in motion by accident.
