21142

# Heathrow Asphalt Plant hot RAP modification

**FM Conway**

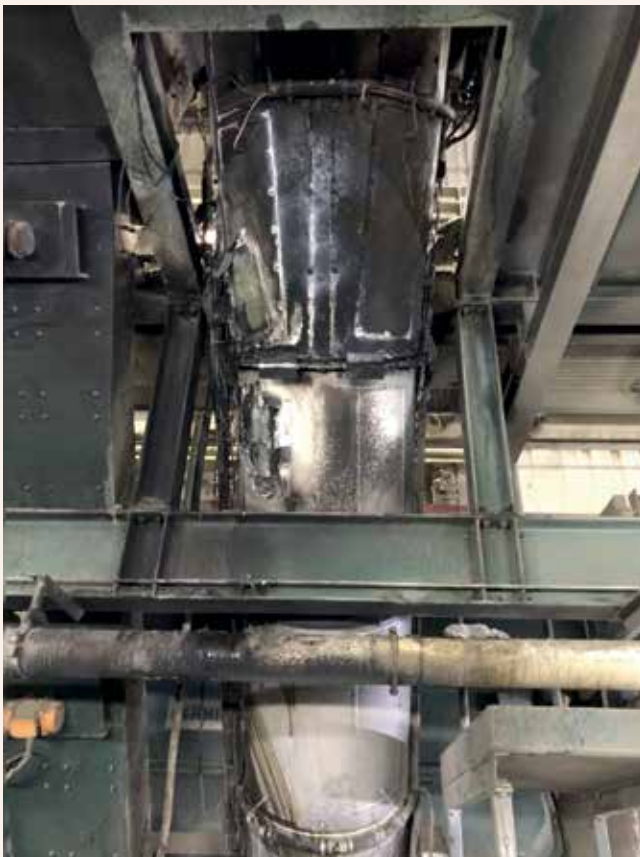
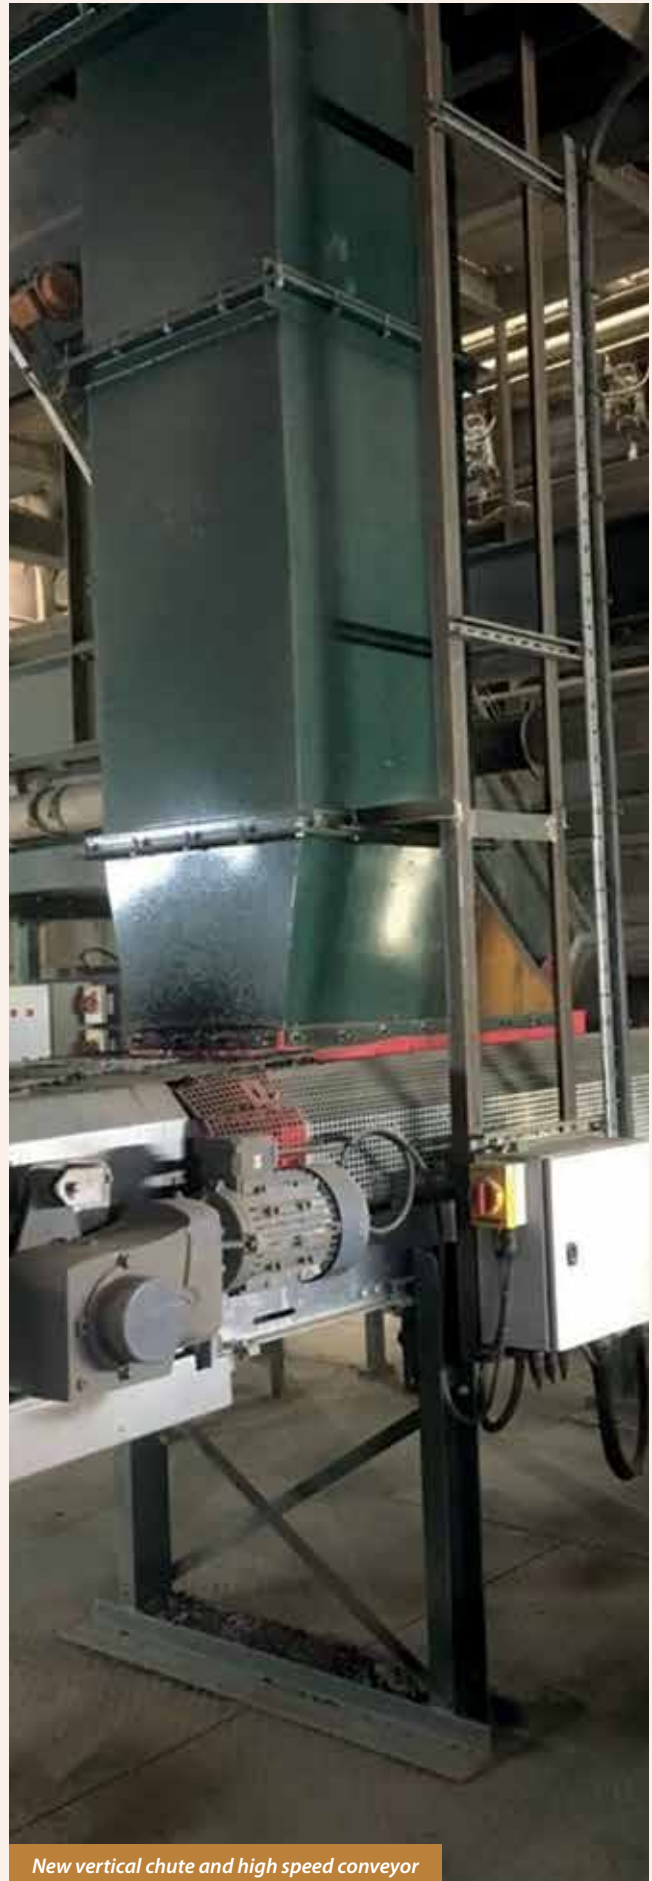
*New vertical chute and high speed conveyor*

The chosen engineered solution to this problem was to remove the angled heated chute and replace it with a vertical chute that fed onto a high-speed conveyor that in turn fed the RAP into the mixer. Neither the OEM nor any of the other engineering companies that FM Conway used regularly on the asphalt plants supported this, leaving FM Conway to manage this innovation.

- The inlet chute to the mixer from the conveyor could not cope with the quantity of material being delivered. This was overcome by removing the chute and fabricating a new chute with increased volume capacity, installing the chute, and testing.
- The conveyor belt scraper could not cope with the adhesiveness of the RAP which during production was accumulating on the belt. A new and more effective belt scraper was installed.
- On the first five or six batches the RAP was slow to discharge from the weigh hopper. The control system can “dose” the RAP from the weigh hopper onto the conveyor belt. It was found that at the beginning of a production run the “dose” timings needed to be increased until the RAP was at optimum temperature allowing the timings to be reduced and expected tph production levels met.
