LOCATION: AGGREGATE DREDGER
ACTIVITY: MAINTENANCE & HOUSEKEEPING
SUB ACTIVITY: N/A

ALERT STATUS: Normal
DATE ISSUED: 01/02/2016 12:49:05
INCIDENT No: 01425

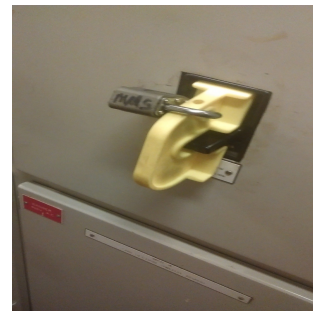
On investigation it transpires that because the switch is made of Bakelite which is hard and also brittle, it is not possible to screw the screw down on to the switch with sufficient purchase to gain enough grip to secure the lockout equipment in place.

This type of Bakelite switch is common on a lot of old plant, not just within the marine industry.

A solution to this problem is currently under investigation.

Highlights the importance of testing and checking all aspects of the lock out process.

Highlights example of an unexpected problem when new elements introduced to lock out procedure.
