Fatal Incident During Unloading

LOCATION:	CONSTRUCTION/DELIVERY SITE	ALERT STATUS:	Normal
ACTIVITY:	TRANSPORT & LOGISTICS / DELIVERY	DATE ISSUED:	25/05/2017 16:12:29
SUB ACTIVITY:	PRODUCT DELIVERY	INCIDENT No:	01445

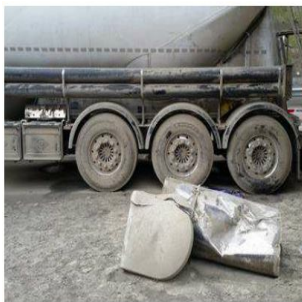
Fallen Filter

While a bulk truck driver was unloading fly ash into the silo, the filter from the customer silo was projected into the air, flew over an adjacent silo, and fell down from a height of approximately 15 meters striking the contractor driver.

As the pressure in the silo increased while the fly ash was being unloaded, the silo filter separated from, the roof of the silo causing it to fall to the ground.

The silo was not equipped with a pressure relief valve (PRV) and the last delivery to this silo was approximately 6 months prior. There was no evidence of a preventative maintenance schedule to ensure the filter was cleaned and functioning properly.
