# 60t Crane Rollover

LOCATION:	ON-HIGHWAY	ALERT STATUS:	Normal
ACTIVITY:	TRANSPORT & LOGISTICS / DELIVERY	DATE ISSUED:	08/08/2017 10:43:48
SUB ACTIVITY:	ON-HIGHWAY	INCIDENT No:	01463

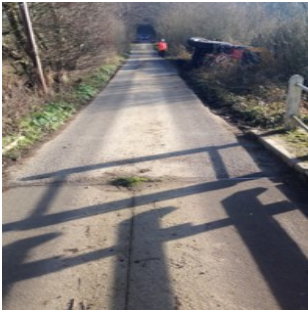
The road is very narrow with foliage on one side, and a soft verge and 5 foot deep ditch on the other. A rut had developed at the roadside and it appears that the front wheel of the crane dropped into this.

Access Road

- Effective journey planning would have identified a different route to site
- Keep away from unmarked edges and soft roadside verges

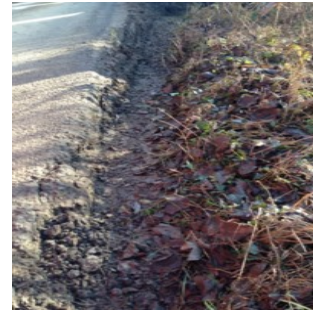
The driver continued onwards and tried to steer the crane out of the rut, but was unsuccessful; the trailing wheels also dropped into the rut and eventually the soft verge gave way, causing the crane to overturn.

Rut to side of road

- Remind drivers about the dangers of soft verges, and how easily a vehicle can roll over.

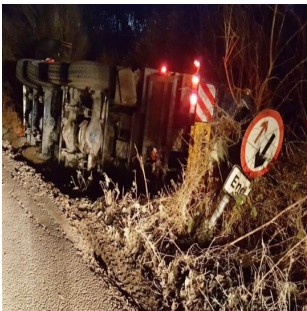
Overtuned Crane

- Wearing a seat belt and not carrying any loose equipment in the cab will help to prevent injuries
- Journey Planning should be undertaken for all deliveries, and could identify where an alternative / safer route is necessary. In this case a movement order had been applied for but had not been issued. The Police had instructed the crane provider to use an alternative route but this had not been communicated to the driver.
