# Asphalt Wagon Doors

ALERT STATUS: Normal  
DATE ISSUED: 08/01/2013  
INCIDENT No: 00351

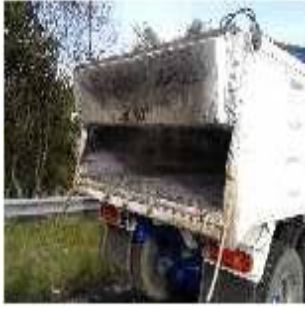
The operative had attempted to free the hydraulic tailgate on an asphalt wagon after it had become stuck whilst attempting to unload into the Paver's hopper.

The wagon driver had managed to raise the bottom of the tailgate using the hydraulic system, but the gate was only halfway open. The operative had then attempted to prise the tailgate open with a bar.

Due to the wagon's body being elevated, the product had rested against the tailgate. When the tailgate eventually became unstuck it swung out trapping the operatives hand between the tailgate's edge and the Paver hopper injuring his index finger and middle finger of his right hand.

The operative suffered a crush injury requiring 2 stitches to one of his fingers. He is very lucky because he could have easily lost his fingers or his hand if the incident had been more severe.

At no time should a contracting operative touch the Asphalt wagon tailgate or attempt to free it by any means (Hydraulic or manual).

If the tailgate becomes stuck stop the operation and if in front of the paver get the driver to pull forward off the paver. It is the responsibility of the wagon driver to open his tailgate. If he cannot open his tailgate in a safe manner then he must take the vehicle off site and return to the Asphalt plant.
