## Load security

ALERT STATUS: Normal  
DATE ISSUED: 09/01/2013  
INCIDENT No: 00355

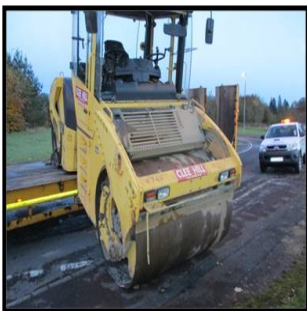
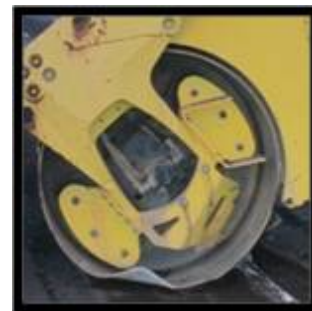
A 10 tonne Bomag 161-AD4 tandem vibratory roller slewed off a low loader trailer during a short journey from a compound to the site. The incident did not result in injury, but could quite easily have led to multiple fatalities as the machine came to rest on a pedestrian footway.

Considerable damage has been caused to the machine amounting to thousands of pounds. Whilst an in depth investigation into the events surrounding the incident is underway, initial findings cite the use of inappropriate restraining devices and the recommended machine tie down points not being used.

- Drivers are trained in loading and securing plant and machines:

- Appropriate restraining devices are used:
- they are checked before use for defects:
- they are capable of withstanding the load to be secured:

- The recommended tie down points are used on the machines:

- The recommended tie down points on the trailer are used:

- Whether it's a long or short journey, make sure it's secured properly.
