Fatal 6 - Vehicle rollover – driver requires 24 stitches

LOCATION:	ON-HIGHWAY	ALERT STATUS:	Normal
ACTIVITY:	TRANSPORT & LOGISTICS / DELIVERY	DATE ISSUED:	18/08/2022 12:40:00
SUB ACTIVITY:	LOADING	INCIDENT No:	03626

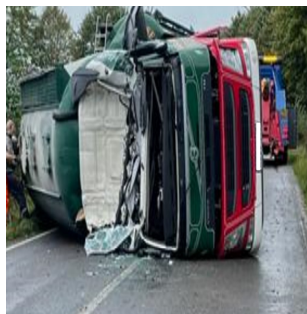
A contract tanker driver was travelling on the A515 when he lost control of the back end of the vehicle and it rolled over, skidding along the road and colliding with another vehicle. It is believed the movement on the back end of the vehicle was caused by catching the soft verge, and when the driver attempted to steer away from the verge this caused the vehicle to destabilise and tip over.

- The driver was wearing his seatbelt which saved him from more serious injury or even death.
- The driver was travelling at 32mph, well within the 50mph limit when the accident occurred.
- Weather conditions were poor with heavy rain and fog patches
- The driver was not using his mobile phone
- The driver had recently completed the MPQC Site Safety Awareness course which covers soft verge / rollover risk

- Remind drivers to wear their seatbelt...This helped avoid serious injuries in this incident.
- Drive to the weather conditions not to the speed limit; travelling significantly lower than the limit reduced the severity of this incident.
- Consider whether alternative routes are available that avoid known local hazard spots.
- Confirm Driver inductions make specific reference to known hazards, such as soft verges in this case.
- Liaise with local councils as appropriate to see if road improvements can be made.
