Slips, trips and falls - 2 incident involving falls on a quarry crusher

LOCATION: QUARRY
ACTIVITY: MAINTENANCE & HOUSEKEEPING
SUB ACTIVITY: CRUSHERS

ALERT STATUS: Normal
DATE ISSUED: 30/07/2023 20:22:43
INCIDENT No: 03653

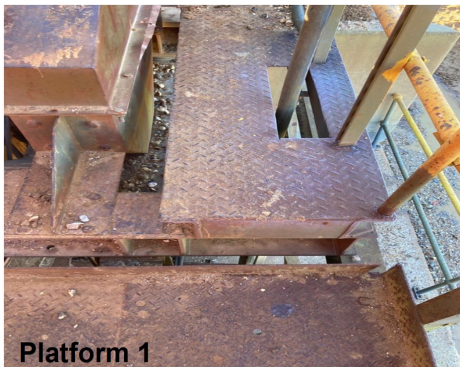
1st incident - An employee was checking to see if there was a fault on a quarry crusher. As he left the area, his boot lost grip due to the wet conditions and he fell backwards, landing on the crusher walkway with his head striking the kickplate. This resulted in a laceration to the back of his head which required 7 stitches and glue to seal the wound.

- Are flooring surfaces and hand holds appropriate for the working environment?
- Is the area for the task level and free of tripping hazards with sufficient space to carry out the task?
- Are there opportunities to make improvements to working areas to minimise the risk of slips, trips and falls?
- Are tasks that are likely to be carried out considered in the design of working areas?
- Are Get a Grip principles practiced and enforced?
- Is Take 5 used prior to doing non routine tasks?

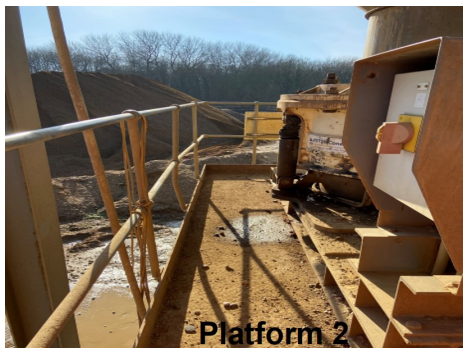
2nd incident - A contractor fell whilst manually guiding parts of the crusher that were being lifted in to place. He lost his footing as he stepped backwards, falling against the handrail, causing scrapes and bruising to his arm, including a puncture wound that required stitches.
