Fatal 5 - Operator sustains finger injury after being trapped whilst assisting with the unloading of bags using a telehandler

LOCATION:	DEPOT	ALERT STATUS:	Normal
ACTIVITY:	LOADING AND UNLOADING	DATE ISSUED:	09/08/2023 19:55:29
SUB ACTIVITY:	NO SUB ACTIVITY AVAILABLE	INCIDENT No:	03658

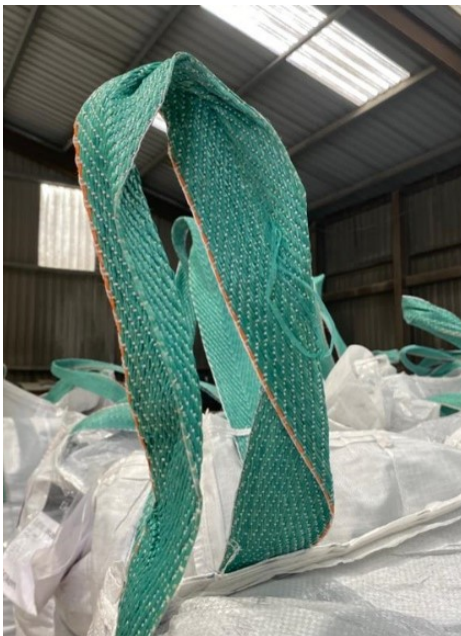
A telehandler operator was unloading a micro-silica delivery and transporting 1.2 tonne bulk bags. After 8 bags had been successfully off loaded and stored, the 9th bag fell off the pallet and onto the floor; each bag has four loops / straps, two of which got caught half underneath the bag.

Image shows a bulk bag lifting loop.

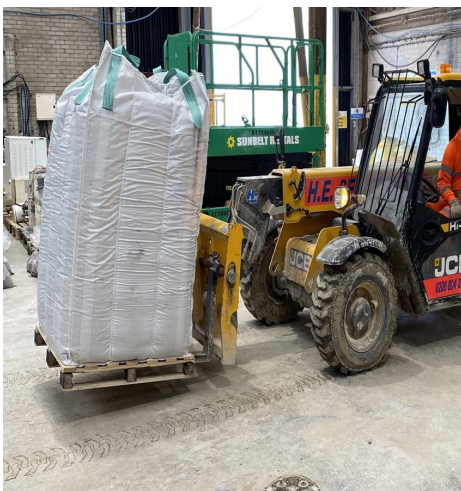
The injured person saw what had happened and went over to help, he put the two top straps on the telehandler tyre, he then pulled on the two trapped straps and asked the telehandler operator to drive the forks through so that the bag could be stood up.

During this process, the straps became taught, trapping the injured person's third finger on his left hand. As the pressure came on the injured person pulled his hand away, leaving his glove and the very end of his finger trapped under the strap, resulting in an open fracture of the bone.

- Ensure loads are secure before attempting to transport them
- Only use suitable vehicle access routes
- Enforce exclusion zones around operational mobile equipment
- Stop & Think and Take 5 in event of unexpected circumstances

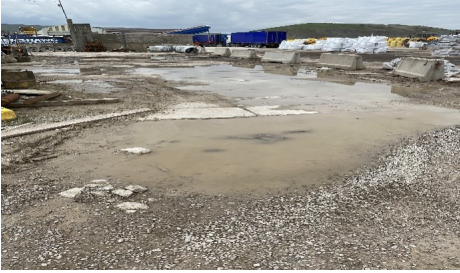
- Incorrect route taken to transport load as regular route was blocked by other vehicle - image shows route

- Unstable load was transported to storage area
- Take 5 training had recently been carried out
- Take 5 assessment had not been carried out for this non-routine task
- Communications between the forklift truck operator and colleague not effective
- Both employees are relatively new to the team

- Are safe designated vehicle routes clearly identified and maintained?
- Do we use the “thumbs up” rule to ensure vehicle operators and pedestrians are aware of each other?
- Are exclusion zones enforced around operational mobile plant, particularly for those guiding vehicle movements?
- Are Safe Systems of Work in place and communicated effectively
- Is Take 5 used prior to doing non routine tasks?
- Do we ensure new team members are aware of the hazards and risks of their role through effective induction and regular ongoing training?
