TRANSPORT - Fatal 6 - External haulier wheel separation – M4

LOCATION:	ON-HIGHWAY	ALERT STATUS:	Normal
ACTIVITY:	TRANSPORT & LOGISTICS / DELIVERY	DATE ISSUED:	20/09/2023 11:08:13
SUB ACTIVITY:	DELIVERING CEMENT	INCIDENT No:	03669

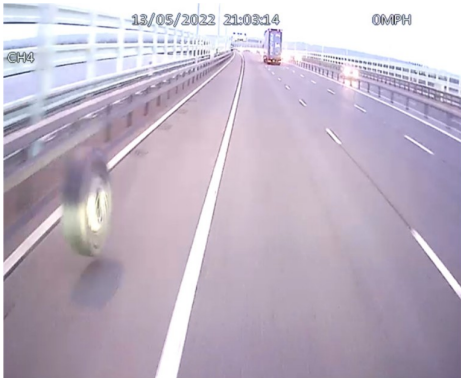
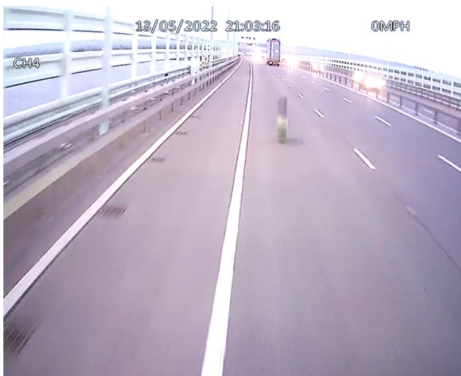
A loaded cement tanker was driving on the M4 Severn Crossing bridge when it experienced a wheel separation on the near side drive axle. The outer wheel came free and undertook the vehicle, this wheel was not recovered. The inner wheel came free to rest by the vehicle as it came to a stop, this wheel was recovered.

Images from rear camera

Images from forward facing camera

Manufacturers provide specific guidance on the requirement when removing and fitting wheels included cleaning the wheel face plate and applying lubricant. In this case, there is evidence to suggest that this preparation had not been completed. Also, the driver did not carry out his first use check.

All wheels on Unit / Trailer should be fitted with wheel nut indicators to alert the driver to any movement of wheel nuts. If any wheel nuts are missing – you must follow your company procedure and replace immediately.

When a wheel is removed – the wheel torque procedure must be adhered to in full – all drivers must be familiar and understand their own hauliers procedure'

When a wheel has been removed – the wheel nuts are most susceptible to experience a loss of torque within its first week (this can be in excess of 800miles!). Drivers and operators must always be vigilant to this.

It is imperative that drivers undertake a thorough vehicle walkaround check for each TractorUnit / trailer driven within the shift with time & care taken to inspect each tyre / wheel as per training.

Tyres / wheels should be visually monitored throughout the shift for any changes in condition or shift in wheel nut indicator position.

Tyre fitters / workshops MUST follow the manufacturers guidelines when replacing wheels

All of the team must be signed off on their training and company procedures, which must cover the wheel cleaning requirements, lubrication requirements and re-torque requirements
