TRANSPORT - Fatal 5 - Operator injured when strap snapped and recoiled striking the operator on the ankle

| SUB ACTIVITY: | DELIVERING CEMENT | INCIDENT No: | 03671 |

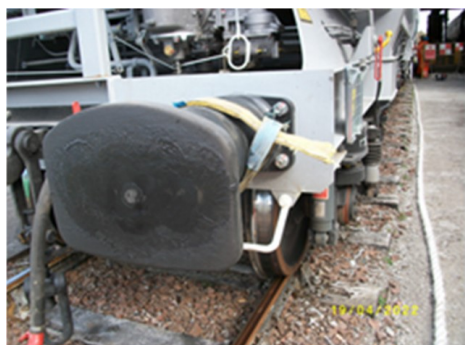
During a JGA rail tanker move using a capstan, the injured person (IP) placed the strap over the buffer-stop with the rope and hook and attached to the strap. Upon the tension being taken up on the capstan rope the strap snapped and recoiled and struck the IP on the ankle, (this is assumed as the IP did not remember much prior to the incident and to getting to hospital).

Image shows broken strap attached to buffer.

- The primary reason the IP was hurt was that he was stood in an unsafe position as per training.
- The person in charge did not clear the area before using the capstan as per training.
- Unauthorised un-serviced equipment (the strap) used for the task.
- Task HIRA and SSoW did not identify the risk or manage the risk.
- There was no management of change , HAZOP or STOP conducted for the new process in 2020.

- Site stopped using JGA wagons at the location where incident occurred
- Safety brief to be conducted to all personnel including any contractors regarding the safe zone.
- A visual safe zone to be painted on the floor to make personnel aware of the safe zone area.
- HIRA and SSoW to be updated to include more detail and communicated to all person involved in the task, include contractors via induction.
- Identify any lifting and other equipment which has not registered to the site and inspect/service remove/dispose.
- A management of change to be conducted if the use of JGA wagons is decided to restart.

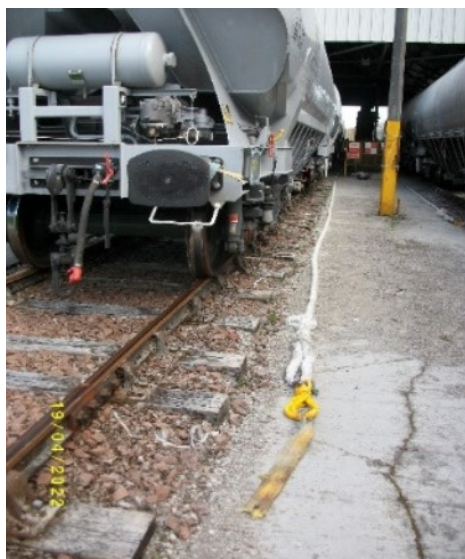
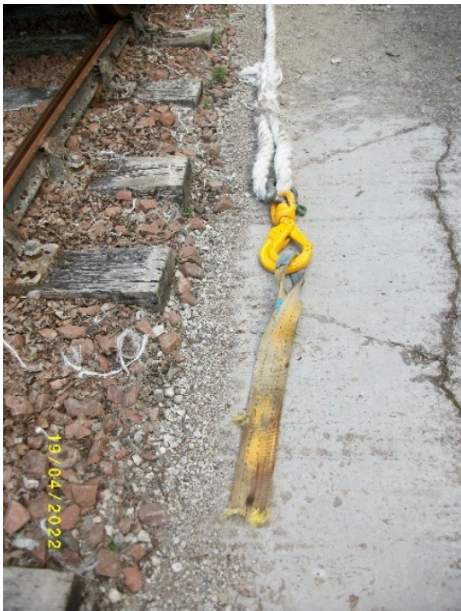
Images show broken strap and rope

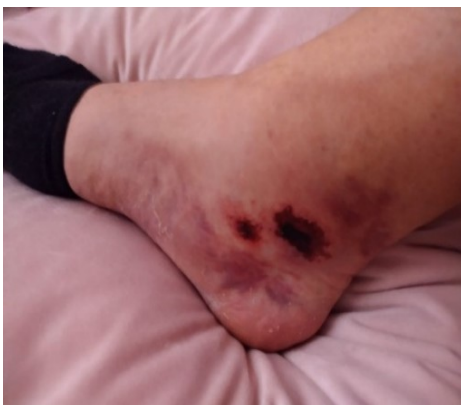
The operator sustained the following injuries, bruising to the ankle, pain to right leg and knee, cut to ear and a graze to head.
