Fatal 1 – Isolation failure - Operative cleaning in banding zone was able to enter the adjacent bagging zone.

| LOCATION: | CONCRETE PRODUCTS PLANT | ALERT STATUS: | High Potential |
| ACTIVITY: | GUARDING AND ISOLATION | DATE ISSUED: | 02/05/2024 15:56:09 |

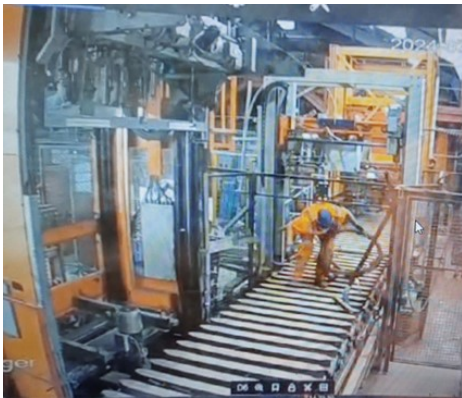
An operative was cleaning in the block plant packaging line using a vacuum cleaner. The operative had followed LOTOTO and was cleaning the bander area. The operative was then able to take the tooling and himself from one zonal area to another as the tunnel through the enclosure guarding was not obstructed by a pack of blocks as it would usually be. The operative activated a sensor in the bagging zone which allowed the bagging machine to activate and the bagger frame to drive forward over the conveyor. The bagger then stayed in position over the conveyor awaiting the next sequential signals to lower. The frame did not lower, and no injuries occurred.

Image below shows operator in the Bander Zone, the bagging zone is in the front of the picture.

- Ensure guarding is effective at all times and can stop persons entering into different zonal areas.
- Product is not to be relied on as guarding between zones.
- Ensure all procedures for isolation and work instructions are effective and all employees have been appropriately.
- Further Information – [MPA Guide to Energy Isolation & LOTOTO](#)
- For more information on isolation please go the Fatal 1 section on the [Safequarry website](#)

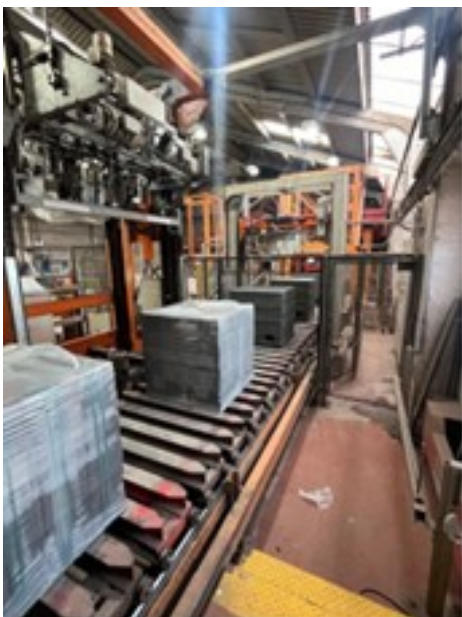
This image shows how the normal production line pack positions prevents passage between different equipment zones.
