Fatal 1 - Operator's hand drawn into rotating shaft of lathe

LOCATION: CONCRETE PRODUCTS PLANT
ACTIVITY: MAINTENANCE & HOUSEKEEPING
SUB ACTIVITY: LATHES

ALERT STATUS: Normal
DATE ISSUED: 21/05/2024 17:25:23
INCIDENT No: 03708

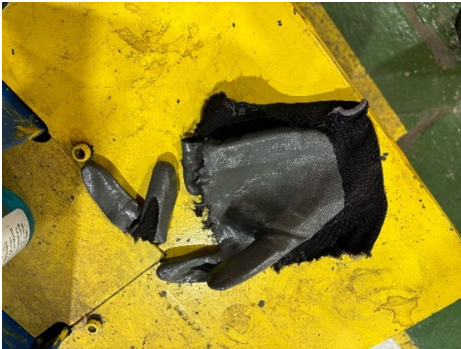
An operator's hand was drawn into a rotating shaft whilst holding emery cloth. The image of his glove below shows how lucky the individual was not to be seriously hurt.

The wearing of gloves increases the risk of entanglement and is never acceptable near rotating parts of machinery such as manual metal working lathes. The wearing of loose, baggy clothing, long hair and jewelery all increase the risk of entanglement.

- Always carry out a suitable and sufficient assessment of the risk from using emery cloth to polish or deburr a shaft. Methods of tooling are available that will achieve the surface finish or close tolerance required for the component.
- Emery cloth should never be applied by hand on manual lathes.
- If after completing a suitable and sufficient risk assessment, it is found that emery cloth does need to be used, there are tools on the market that allow this to be completed without holding the emery cloth by hand. HSE has some great guidance on safe working – links below. Please ensure you watch these
