# Fatal 1 - Operator's hand drawn into rotating shaft of lathe

LOCATION: CONCRETE PRODUCTS PLANT  
ACTIVITY: MAINTENANCE & HOUSEKEEPING  
SUB ACTIVITY: LATHES

ALERT STATUS: Normal  
DATE ISSUED: 21/05/2024 17:25:23  
INCIDENT No: 03708

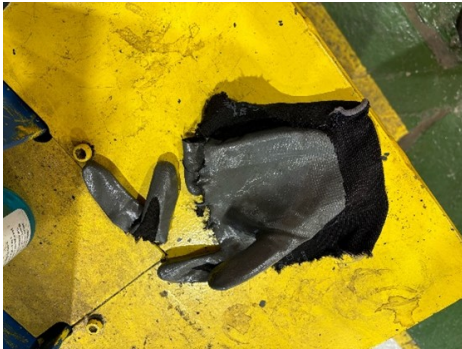
An operator's hand was drawn into a rotating shaft whilst holding emery cloth. The image of his glove below shows how lucky the individual was not to be seriously hurt.

The wearing of gloves increases the risk of entanglement and is never acceptable near rotating parts of machinery such as manual metal working lathes. The wearing of loose, baggy clothing, long hair and jewelery all increase the risk of entanglement.

- Always carry out a suitable and sufficient assessment of the risk from using emery cloth to polish or deburr a shaft. Methods of tooling are available that will achieve the surface finish or close tolerance required for the component.
- Emery cloth should never be applied by hand on manual lathes.
- If after completing a suitable and sufficient risk assessment, it is found that emery cloth does need to be used, there are tools on the market that allow this to be completed without holding the emery cloth by hand. HSE has some great guidance on safe working – links below. Please ensure you watch these
