# Transport - Tipper driver injures leg when walking into Armco barrier

**LOCATION:** READYMIX OR MORTAR PLANT  
**ACTIVITY:** TRANSPORT & LOGISTICS / DELIVERY  
**SUB ACTIVITY:** DELIVERING AGGREGATES

**ALERT STATUS:** Normal  
**DATE ISSUED:** 27/08/2024 12:20:26  
**INCIDENT No:** 03730

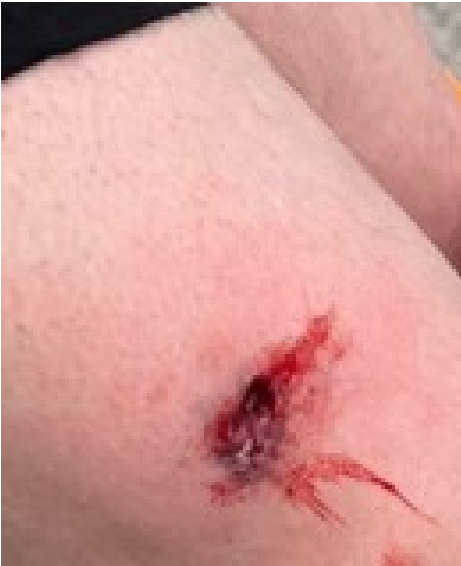
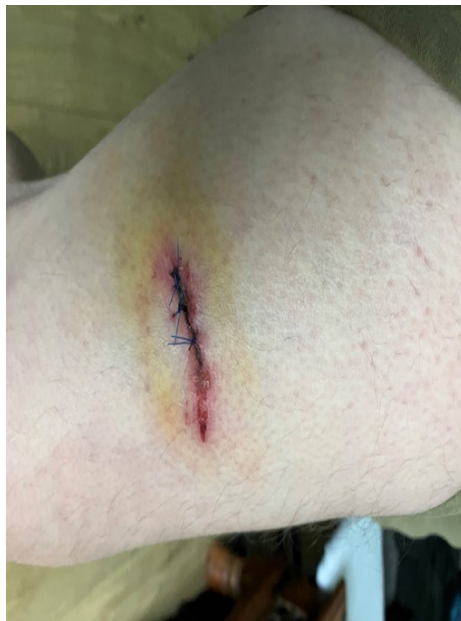
The discharge hopper capacity is 10 tonne, therefore the delivery per vehicle is made up of several tips. Unfortunately, because the hopper is below ground, the level of material in the hopper could not be seen in the vehicle's rear camera therefore, the driver needed to get out and check the level. When the driver was returning to the vehicle cab he deviated off the usual route and walked into the end of a barrier which protects the control panel for the transverse conveyor.

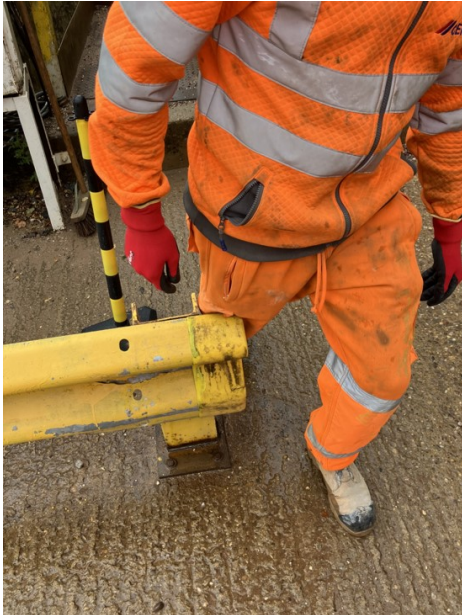
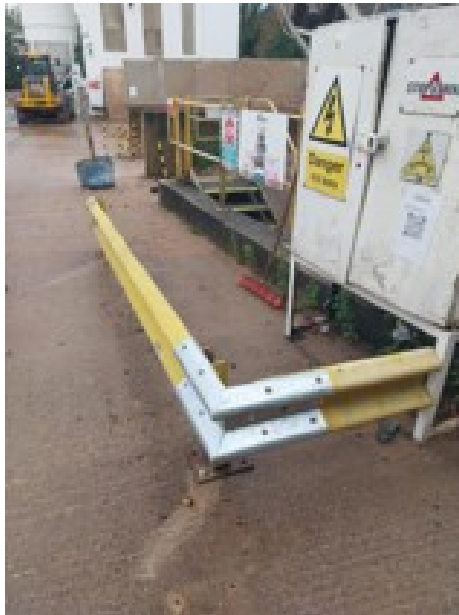
The exposed end of the Armco barrier was not protected. See below the before and after images, these show how a similar incident will be avoided by the changes made after this incident.

The driver didn't carry out a 'Take 5' assessment before delivering. If he had, he may have noticed the barrier and taken extra care around this area and highlighted the hazard via a Near Miss / Hazard Alert card.
