MOBILE PLANT - Fatal 5 - ADT loses wheel in depot

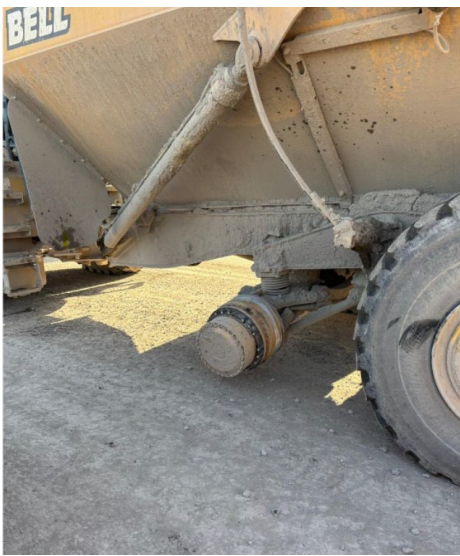
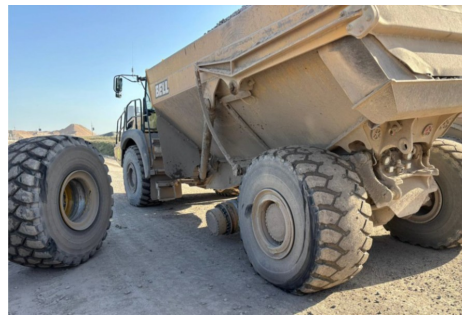
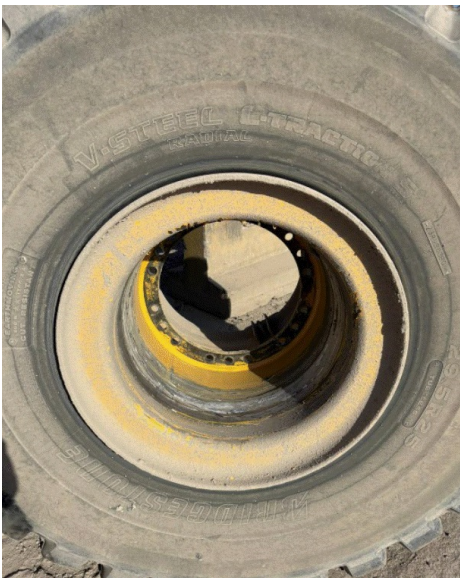
An articulated dump truck (ADT) was hauling material from a train to a stockpile in the depot when the wheel nuts on the central rear nearside wheel failed, causing it to fall off.

An investigation revealed that the wheel hub had been replaced the previous month but it had not been retorqued following the return to use after the repair. The service sheet stipulates that it is the responsibility of the user to ensure that the assembly is checked and retorqued if necessary.

After removal of mobile plant wheels, ensure the wheels are checked and retorqued to prevent the wheel nuts from coming loose.
