LOCATION:	Asphalt/Coating plant	ARTICLE YEAR	2021
ACTIVITY:	Maintenance & Housekeeping	COMPANY:	FM Conway
SUB ACTIVITY:	N/A	COMPANY LOCATION:	Heathrow Asphalt Plant
BEST PRACTICE No:	BP2088	COMPANY TEL:	0000
COUNTRY OF ORIGIN:

Asphalt drum hydro blasting

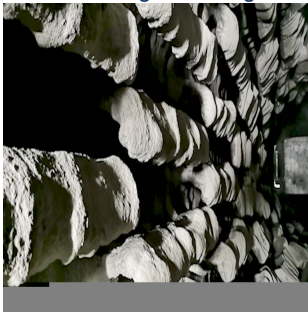
At FM Conway's asphalt plant at Heathrow, it was necessary to regularly remove the build-up of material sticking to the dryer finger lifters in the RAP drum. These fingers lift the material and drop it in front of the heat screen to allow the product to be heated and mixed correctly. Over time, the RAP drum clogged with old material blocking the finger lifters and cooled material stuck to the drum. This causes the plant to run less efficiently and results in more wear and tear on the components due to the increased weight of this material.

Before

FM Conway developed a new system using pressure jets to achieve this.
