BEST PRACTICE

LOCATION: Quarry
ACTIVITY: Power tools and battery safety
SUB ACTIVITY: No Sub Activity Available
BEST PRACTICE No: BP2188
COUNTRY OF ORIGIN:

Lithium battery – Recharger cabinet

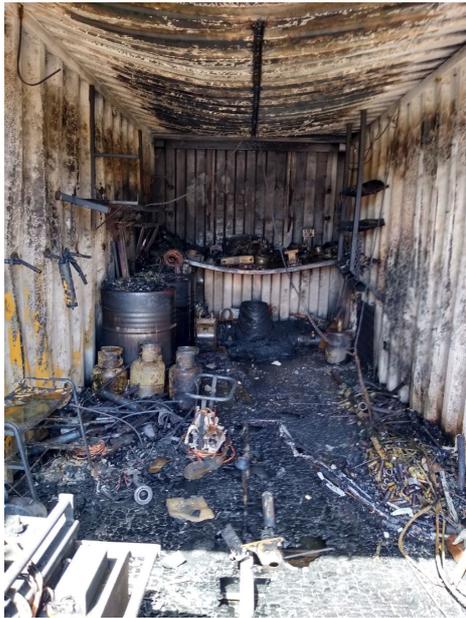
An incident occurred at one of our quarries involving a battery powered impact gun. One of the operators put the battery onto charge in the tool store, which was located in a steel container. Two hours later it was recognised that smoke and visible flames were coming from tool store, the emergency services were called, and the power isolated. The photograph demonstrates the exact nature of the damage created.

- The incident occurred at the charging point for the impact gun charger / lithium-ion battery.
- The impact gun is powered by an 18-volt lithium battery that is charged within a stand-alone 240v charger unit.
- Plant operator put the battery onto charge in the tool store in an 20ft steel container, no defects with the charger or battery were noticed on the pre-charge inspection.

It was situated on a metal shelf and the charger was plugged into 240v internal fitted 3 pin socket which was used on a regular basis with no issues or faults reported.

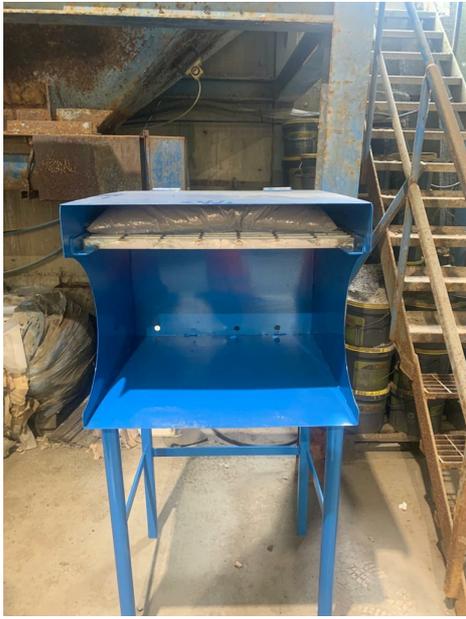
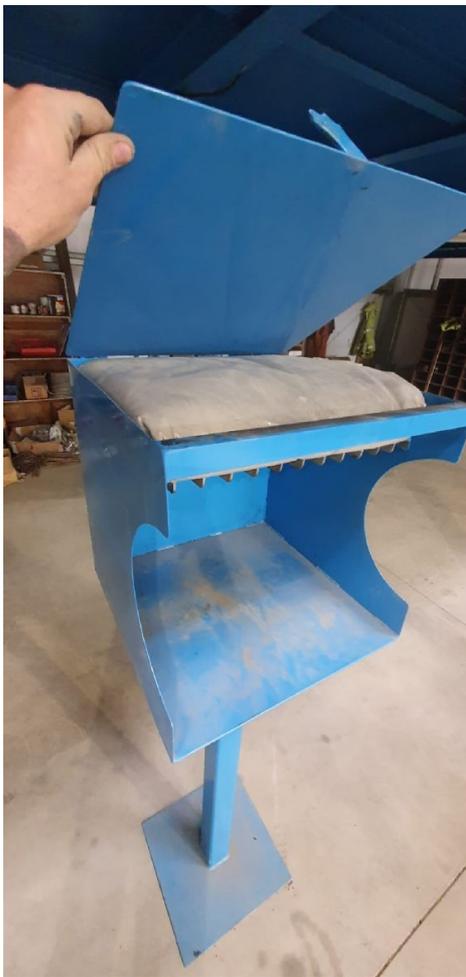
Please see the **additional pdf**, the images below and the video to find out about the solution developed to reduce the risk of fire when re-charging the batteries.

The engineer carried out a risk analysis of charging these types of batteries and started to look at the Hierarchy of Control. The charging of batteries could not be eliminated or substituted as returning to mains cabled power tools in a quarrying environment was reintroducing risk to the operations that had been eliminated with the introduction of battery powered tools.
