BEST PRACTICE

LOCATION:	Quarry	ARTICLE YEAR	2006
ACTIVITY:	Manual handling and storage	COMPANY:	Aggregate Industries
SUB ACTIVITY:	N/A	COMPANY LOCATION:	Duntilland Quarry, North Lanarkshire
BEST PRACTICE No:	BP306	COMPANY TEL:	0777 5821507
COUNTRY OF ORIGIN:	United Kingdom

Hose reel

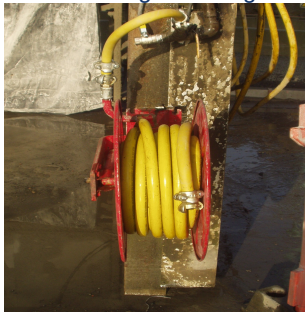
One of the main causes of health and safety incidents at Duntilland is from slips, trips and falls caused by objects left on the ground. The long water hose, which is used to fill the water tanks on trucks, is the main problem. In order to avoid the possibility of the hose lying around, a fire reel has been installed, which can be swivelled around a vertical pivot and has been placed at a suitable height to prevent the need to bend over, thus reducing the risk of back problems. A warning sign has also been installed as a reminder that the hose should be wound back onto the reel after use.

hose reel
