## BEST PRACTICE

**New hopper to remove semi-dry concrete sticking**

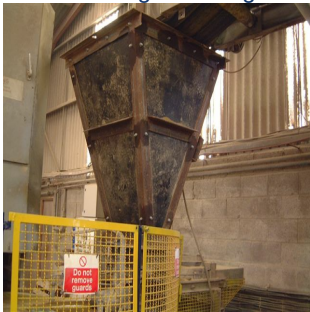
**rubber hopper close-up**

The machine operator led the development of a hopper lined with thick conveyor rubber. This has produced a hopper that rarely suffers from build-up of semi-dry concrete. This solution has also removed the need for heavy manual intervention as, on the infrequent occasions that the material does build up, a simple tap on the side removes it.

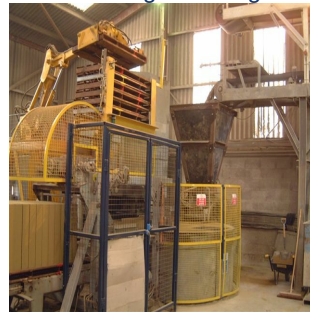
**rubber hopper in the distance**
