## Chromate identification & quantification video

Breedon GB Materials > Hope Cement Works

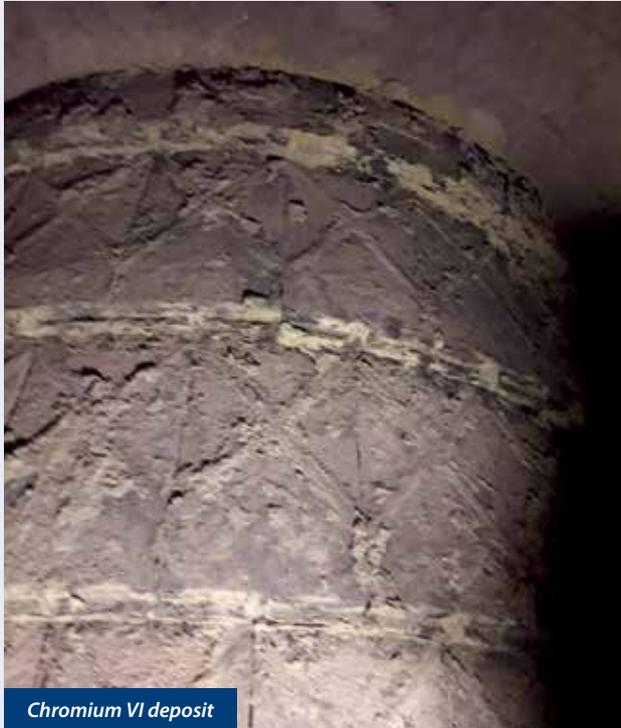
Chromium VI deposit

The study revealed that Chromium VI was present in one location, on the vortex plates and, during refractory removal from the vortex ring. Chromium VI levels were recorded above the workplace exposure limit.
