INCIDENT ALERT

LOCATION:	COMPANY-WIDE	ALERT STATUS:	Normal
ACTIVITY:	MAINTENANCE & HOUSEKEEPING	DATE ISSUED:	01/10/2015 21:30:38
SUB ACTIVITY:	N/A	INCIDENT No:	01419

Failure to isolate results in electrical burns

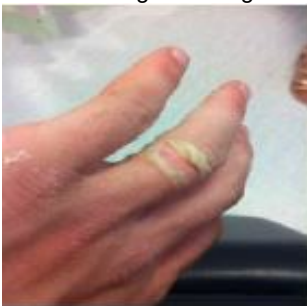
A contractor was called to a site after a fault was reported with a hired generator. Whilst tightening the bolts on the lift pump using a socket wrench the contractors' ring came into contact with the exposed positive terminal of the starter motor. Despite wearing latex gloves, the ring became instantly heated causing the contractor to sustain a burn to the finger.

On examination it was found that a number of terminals of the starter motor were exposed due to poorly fitting rubber insulating covers. The contractor had commenced work on the generator without isolating or disconnecting the battery. This was not in accordance with the contractors risk assessment and method statements, or the guidance provided on the door of the container housing the generator. In a statement given by the contractor, he stated that he "...didn't feel that there would be any danger from a 12 Volt battery".

The calculation below shows the current would have been circa 120 amps even though it was only using a 12 volt battery. If contact had been maintained for 1 to 2 seconds, a gold ring would have heated to temperatures of around 700°C

This calculation is based on the likely resistance of the whole electric circuit being around 0.1 ohm (the sum of the very low resistance of the ring, and the internal resistance of the battery, plus the resistance of the contact points).

$$I = V/R = 12 \text{ volts}/0.1 \text{ ohm} = 120 \text{ amps}$$

- When carrying out any electrical work isolate and test before you touch!
- Remove; metal bracelets, watches and rings and wear appropriate hand protection when handling batteries.
