Failure to isolate results in electrical burns

ALERT STATUS: Normal
DATE ISSUED: 01/10/2015 21:30:38
INCIDENT No: 01419

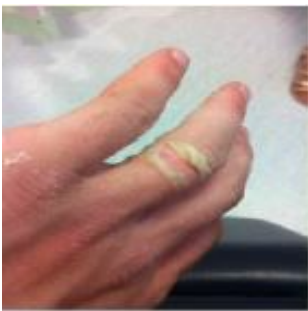
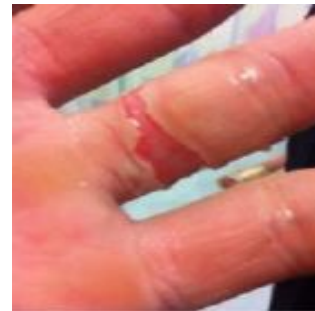
A contractor was called to a site after a fault was reported with a hired generator. Whilst tightening the bolts on the lift pump using a socket wrench the contractors' ring came into contact with the exposed positive terminal of the starter motor. Despite wearing latex gloves, the ring became instantly heated causing the contractor to sustain a burn to the finger.

On examination it was found that a number of terminals of the starter motor were exposed due to poorly fitting rubber insulating covers. The contractor had commenced work on the generator without isolating or disconnecting the battery. This was not in accordance with the contractors risk assessment and method statements, or the guidance provided on the door of the container housing the generator. In a statement given by the contractor, he stated that he "...didn't feel that there would be any danger from a 12 Volt battery".

The calculation below shows the current would have been circa 120 amps even though it was only using a 12 volt battery. If contact had been maintained for 1 to 2 seconds, a gold ring would

have heated to temperatures of around 700°C

This calculation is based on the likely resistance of the whole electric circuit being around 0.1 ohm (the sum of the very low resistance of the ring, and the internal resistance of the battery, plus the resistance of the contact points).

$$I = V/R = 12 \text{ volts}/0.1 \text{ ohm} = 120 \text{ amps}$$

- Are Contractors registered on the MPA National Contractor Database?
- Have they completed the industry Contractor Safety Passport?
- Ensure Contractors coming onto your site are competent to do the work they have been employed to do;
- Contractors must receive a site induction;
- Risk assessment and Method statements should be reviewed with contractors prior to commencing work.

- Risk assessments and Method statements should be fit for purpose, specific to the work planned and understood by those undertaking the task;
- Contractors should not be left to their own devices once on site. Regular supervision visits are required to ensure they are following their own safe systems of work and site rules.
- Once work is completed ensure any plant is handed back in a safe condition and obtain feedback along with discussion on any improvements to Health and Safety, required for future work.
- When carrying out any electrical work isolate and test before you touch!
- Remove; metal bracelets, watches and rings and wear appropriate hand protection when handling batteries.
