# Fingers caught in Vee Belt

LOCATION: LIME & SLAG PLANTS  
ACTIVITY: MAINTENANCE & HOUSEKEEPING  
SUB ACTIVITY: N/A

ALERT STATUS: Normal  
DATE ISSUED: 20/11/2015 14:58:48  
INCIDENT No: 01423

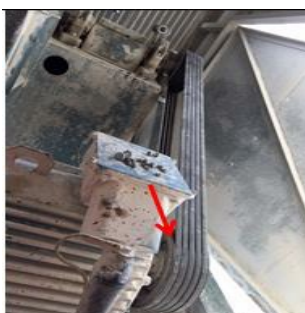
- Operator reported to maintenance that the fan was sounding noisy.
- Maintenance leader informed operator that he would be there in 10 minutes.
- Injured person (IP) made decision to assist operator with guard removal due to its size; top half section of guard removed.
- Vee belts were left on in tension.
- Using stillsons on the drive end shaft, operator attempted to turn fan and motor anticlockwise, very little movement.
- Both personnel stopped to discuss the work.
- IP placed right hand on top of belts on drive end pulley, with his left hand fingers in the nip point between the vee belts and drive pulley.
- The belts moved and at this point IP fingers were caught in the pulley leading to loss of the ends of middle and ring finger of left hand; also severe laceration and fracture to little finger.

Nip Point

- Body parts in danger areas i.e. line of fire.
- Although fan unit was locked off i.e. to prevent starting of unit, the immobilisation of equipment where other hazards exist was not done i.e. releasing the vee belt tension.
- Scope of work was more than investigative i.e. why the fan was noisy to actual maintenance fault diagnosis.

- Always position body parts away from line of fire i.e. in this case in a nip point.
- The isolation and immobilisation of equipment process needs to be understood and carried out by all personnel. In addition to the obvious locking off and checking for dead the electrical drive systems, any systems where there is an additional hazard identified, they should be removed and isolated. In this case the vee-belt tension released.
