Operator suffers allergic reaction when doused in cleaning fluid whilst using pressure washer to clean plant

ALERT STATUS:	Normal
DATE ISSUED:	31/08/2017 11:49:21
INCIDENT No:	01467

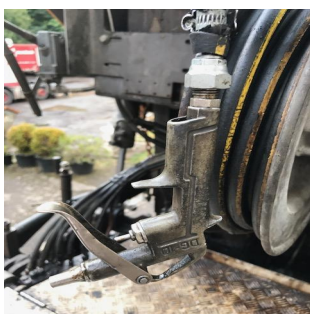
The operative was cleaning down his machine paver using the wash-down system on the paver, which consists of a pump-driven hand-held lance, mounted on a retracting hose reel.

On retracting the reel, the lance became detached from the hose, and as the pump was still running, the fluid continued to flow from the hose, covering the operator on his face, head and down his top.

A review of the incident revealed that the hose clip connecting the hose to the lance had failed.

1. Ensure plant and equipment is well maintained, in this case the hose clip connection failed under the force of pulling the lance against the hose.
2. Ensure PPE is worn as detailed in the COSHH assessment. In this case, if he had been wearing a hard hat and visor, the extent of the skin contact would have been reduced.
3. Ensure above points are applied to all pressure washing activities, including vehicle cleaning.
