## INCIDENT ALERT

**LOCATION:** AGGREGATE DREDGER  
**ACTIVITY:** MAINTENANCE & HOUSEKEEPING  
**SUB ACTIVITY:** N/A

**Smouldering Fire Cloth**

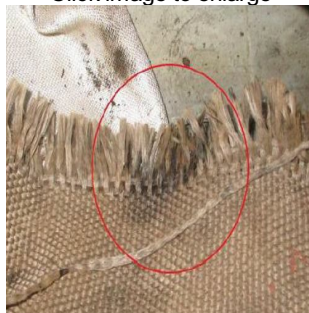
A risk assessment had been completed, control measures implemented and the permit to work issued. Just after welding began, smoke started to emit from the fire cloth next to where welding was taking place. As the cause of this was not clear, and as a precaution to prevent any fire spreading, a closely sited fire extinguisher was used on the area that was smoking. The fire cloth was then taken out into the open air.

The Ship's Safety Officer's investigation identified that prior to use, the fire cloth had become contaminated with grease / oily residue and the sparks from the welding operation had caused the fire cloth to begin to smoulder.

- Competent Persons to ensure that all equipment is thoroughly inspected prior to the start of hot work or any work where there is risk of fire.
- Shipboard Safety Officers to verify at their statutory safety officer inspections, that fire prevention and fire fighting equipment is not exposed to contamination or deterioration.
- Fire cloths or other fire prevention equipment must be clearly quarantined or marked accordingly if found to be contaminated so that it is not inadvertently used prior to discarding ashore.
