INCIDENT ALERT

LOCATION:	AGGREGATE DREDGER	ALERT STATUS:	Normal
ACTIVITY:	MAINTENANCE & HOUSEKEEPING	DATE ISSUED:	19/02/2019 10:32:13
SUB ACTIVITY:	N/A	INCIDENT No:	01505

Confined Space - Serious Near Hit

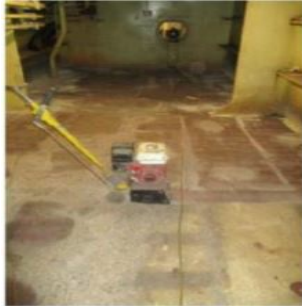
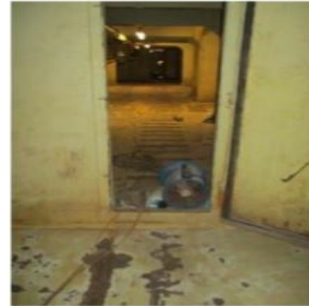
The task involved using a power scarifier to clear paint and rust from steel surfaces. The tank was gas free and certificated before work commenced with a yard entry certificate running for 24 hours. Initially the contractors used an electric 110v scarifier unit, but as they moved along the voids they encountered power drop issues on the electric unit with the length of power leads used. The contractors changed from the electric motor unit to a petrol engine unit and continued working throughout the day.

On leaving site they reported feeling dizzy and unwell and visited the local hospital, where they were found to have high carbon monoxide blood readings and were placed on oxygen for 2 hours before being discharged. The carbon monoxide was created from the exhaust of using a petrol machine in an enclosed space.

- No company personnel were informed of the near hit until the following day;
- Risk assessment did not include the use of power tools or the petrol scarifier;
- The permit issued from the yard did not include petrol equipment.
