INCIDENT ALERT

LOCATION:	CONTRACTING - ON-HIGHWAY	ALERT STATUS:	Normal
ACTIVITY:	MAINTENANCE & HOUSEKEEPING	DATE ISSUED:	14/06/2019 09:40:40
SUB ACTIVITY:	N/A	INCIDENT No:	01515

Failure of Suspension Airbag

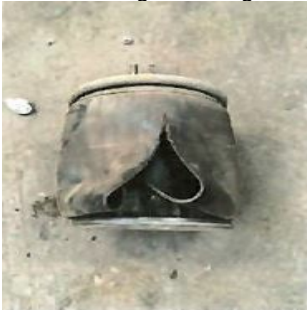
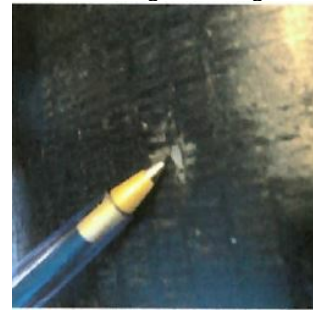
ACCIDENT / INCIDENT IMAGES

The injured party (IP) was carrying out maintenance work on the underside of a trailer unit. Near the end of the maintenance, the IP was stood in the pit working on the underside of the trailer near the axle, when the suspension airbag to the right exploded.

The result of this release and the noise created was sufficient enough to cause temporary hearing loss and strained the IP's neck area. The IP was treated by the first aider on site and later attended hospital. The incident caused no permanent damage to the ear and normal hearing returned a short time after. The failure of the suspension bag was caused by either a stone or other object that was trapped between the pedestal and the air bag, causing a cut, allowing the bag to fail under pressure. After researching similar events, the potential for this incident to have caused far greater levels of injury cannot be understated. Trauma because of airbag explosion/deployment is not uncommon - injuries have usually been sustained because of failure or misuse of the system. In one incident, a 53-year-old man was attempting to repair the suspension airbag on the undercarriage of his articulated vehicle. To save time he decided not to raise the vehicle. The air bag spontaneously ruptured causing massive trauma to the patient. His injuries were facial lacerations, a fractured mandible, loss of teeth, displacement of his denture and would have needed ongoing rehabilitation and support. The patient in this case was extremely fortunate.

- Understand the potential of suspension airbags to cause harm - For underside 'suspension airbag inspections', a face shield and hearing protection must be worn at all times, until the inspection is complete. - When general maintenance is being undertaken on the underside of the trailer, the air must be fully released from the suspension system - Eliminate/Reduce the risk where practicable, removal of air, pressure, stored energy - always follow the correct procedures - Treat any pressurised or closed pressurised system with care and if in any doubt as to the systems integrity, stop and report this to supervisors/managers immediately
