INCIDENT ALERT

LOCATION:	CONTRACTING - ON-HIGHWAY	ALERT STATUS:	Normal
ACTIVITY:	MAINTENANCE & HOUSEKEEPING	DATE ISSUED:	14/06/2019 09:40:40
SUB ACTIVITY:	N/A	INCIDENT No:	01515

Failure of Suspension Airbag

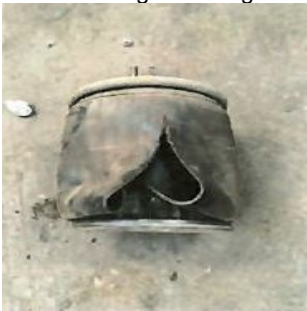
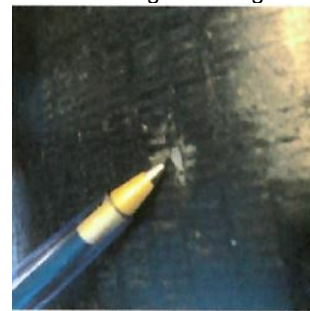
The injured party (IP) was carrying out maintenance work on the underside of a trailer unit. Near the end of the maintenance, the IP was stood in the pit working on the underside of the trailer near the axle, when the suspension airbag to the right exploded.

The result of this release and the noise created was sufficient enough to cause temporary hearing loss and strained the IP's neck area. The IP was treated by the first aider on site and later attended hospital. The incident caused no permanent damage to the ear and normal hearing returned a short time after. The failure of the suspension bag was caused by either a stone or other object that was trapped between the pedestal and the air bag, causing a cut, allowing the bag to fail under pressure. After researching similar events, the potential for this incident to have caused far greater levels of injury cannot be understated. Trauma because of airbag explosion/deployment is not uncommon - injuries have usually been sustained because of failure or misuse of the system. In one incident, a 53-year-old man was attempting to repair the suspension airbag on the undercarriage of his articulated vehicle. To save time he decided not to raise the vehicle. The air bag spontaneously ruptured causing massive trauma to the patient. His injuries were facial lacerations, a fractured mandible, loss of teeth, displacement of his denture and would have needed ongoing rehabilitation and support. The patient in this case was extremely fortunate.

- Understand the potential of suspension airbags to cause harm - For underside 'suspension airbag inspections', a face shield and hearing protection must be worn at all times, until the inspection is complete. - When general maintenance is being undertaken on the underside of the trailer, the air must be fully released from the suspension system - Eliminate/Reduce the risk where practicable, removal of air, pressure, stored energy - always follow the correct procedures - Treat any pressurised or closed pressurised system with care and if in any doubt as to the systems integrity, stop and report this to supervisors/managers immediately
