INCIDENT ALERT

LOCATION:	READYMIX OR MORTAR PLANT	ALERT STATUS:	Normal
ACTIVITY:	LIFTING	DATE ISSUED:	12/09/2019 19:42:46
SUB ACTIVITY:	NO SUB ACTIVITY AVAILABLE	INCIDENT No:	01527

Contractor loses 4 fingers during lifting operation - £400K fine for company

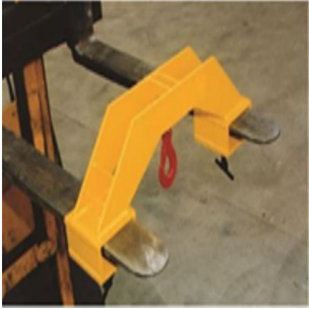
Correct lifting device

- Ensure attachment (picture example below) is used when using slings or chains on FLT to prevent the load from moving.
- Ensure there are clear procedures / processes on site to prevent unauthorised access to mobile plant. Where contractors are required to use items of mobile plant, a copy of their competencies MUST be held seen on induction.

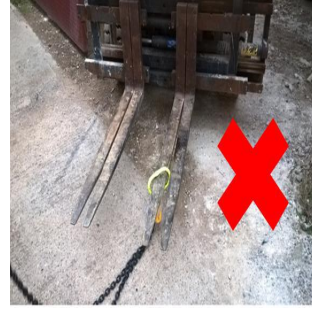
Sixth opportunity to stop this incident All lifting operations MUST have a Lift Plan which details any lifting attachment required. The investigation revealed the following; That no lift plan had been completed for the lifting operations to flip the muck gate over. As a result of this, the correct equipment was not selected for the lifting and slinging of the muck gate. One of the contractors was a trained lifting and slinging operator. The P2P identified lifting and slinging, but the absence of the lift plan was not challenged when issuing the P2P. Inappropriate lifting equipment was used to sling the muck gate, using chains with no FLT slinging attachment. The lifting chains were attached to the FLT forks (see picture below) which allowed the muck gate to slip when the forks were lifted.

Lifting device used in incident
