## INCIDENT ALERT

LOCATION:	READYMIX OR MORTAR PLANT	ALERT STATUS:	Normal
ACTIVITY:	LIFTING	DATE ISSUED:	12/09/2019 19:42:46
SUB ACTIVITY:	NO SUB ACTIVITY AVAILABLE	INCIDENT No:	01527

Contractor loses 4 fingers during lifting operation - £400K fine for company

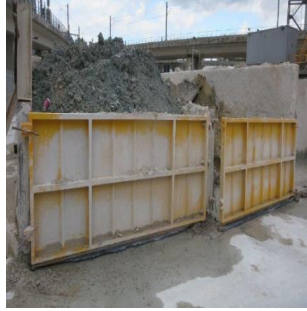
A site maintenance manager instructed a contractor to fabricate three new gates for some waste material bays at a readymix plant. The contractor and a colleague were fabricating the 3rd of the 3 gates at the plant (see pictures below). Whilst trying to flip the metal gate over using a fork lift truck and lifting chains, the metal gate slipped and trapped one of the contractor's fingers on his right hand.

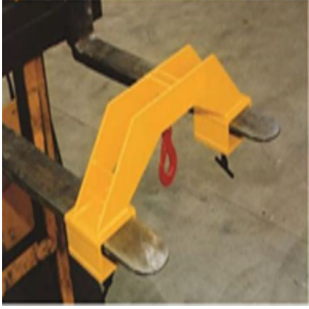
**Correct lifting device**

- Ensure attachment (picture example below) is used when using slings or chains on FLT to prevent the load from moving.
- Ensure there are clear procedures / processes on site to prevent unauthorised access to mobile plant. Where contractors are required to use items of mobile plant, a copy of their competencies MUST be held seen on induction.

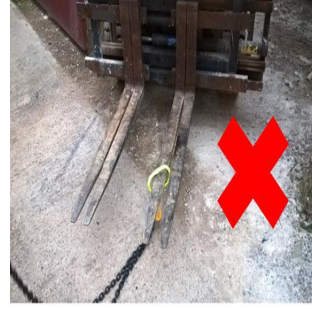
**Lifting device used in incident**

**Sixth opportunity to stop this incident** All lifting operations MUST have a Lift Plan which details any lifting attachment required. The investigation revealed the following; That no lift plan had been completed for the lifting operations to flip the muck gate over. As a result of this, the correct equipment was not selected for the lifting and slinging of the muck gate. One of the contractors was a trained lifting and slinging operator. The P2P identified lifting and slinging, but the absence of the lift plan was not challenged when issuing the P2P. Inappropriate lifting equipment was used to sling the muck gate, using chains with no FLT slinging attachment. The lifting chains were attached to the FLT forks (see picture below) which allowed the muck gate to slip when the forks were lifted.
