INCIDENT ALERT

LOCATION: CONCRETE PRODUCTS PLANT
ACTIVITY: MAINTENANCE & HOUSEKEEPING
SUB ACTIVITY: N/A

Fatal 6 - Operative hit in face by airline - correct use and adjustment of airlines

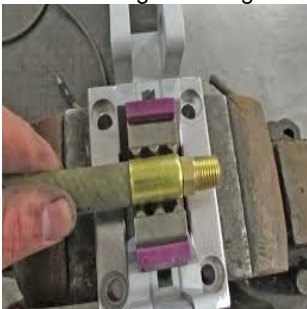
Mechanical crimped fitting

Review all airlines for suitability of use and type of fastener to secure the fitting. • Ensure the hoses used are made to British Standard for the application you are using. • Ensure the fitting is the correct size for the hose being used. • When adjusting any airline fitting, use a fresh, clean and undamaged part of the correct hose when fastening the fitting. • Use the appropriate fastener for your pressure applications. Seek advice from a hose specialist. • High pressure applications should use mechanical fabricated fitted or crimped fastenings. • The preferred mechanical fastenings shown below can be done in house with the correct equipment and training.
