INCIDENT ALERT

LOCATION: CONTRACTING - ON-HIGHWAY
ACTIVITY: ACCESS & EGRESS & WORKING AT HEIGHT
SUB ACTIVITY: N/A

Near Miss - Hydraulic Hose Failure

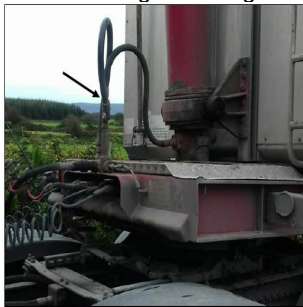
There was a Near Miss incident whereby the hydraulic hose on a tar truck burst at its joint which resulted in hydraulic oil being sprayed onto the upper back and neck area of one of our Contracts Supervisors who was standing c.4-5 metres away. Fortunately, the truck body was being lowered at the time of the incident and as such the hydraulic system was not operating at full 'high pressure', in addition the oil temperature was low and as such there was no injection injury or burn sustained.

- This incident highlights the importance of wearing all requisite items of protective clothing and in particular safety glasses, had the Supervisor in question being facing the truck he may have been exposed to the risk of serious eye injury.
- Personnel should not stand within the fall radius of a raised tipper body during tipping and lowering operations.
- Although this type of incident tends to occur suddenly and without warning or prior signs of hose deterioration, visual inspections should be undertaken for signs of leakage or weeping, particularly at mechanical joints.
- Ask your team, "Could a similar incident happen on our site and if so, what are we going to do to make sure it doesn't?".
