INCIDENT ALERT

LOCATION: ASPHALT/COATING PLANT
ACTIVITY: GUARDING AND ISOLATION
SUB ACTIVITY: NO SUB ACTIVITY AVAILABLE

Fatal 6 - Faulty isolators - Craig and Derricott

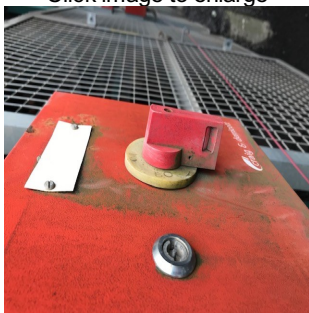
During a recent maintenance activity, it was noticed that the isolators (see images) could be locked in the ON position and also can be switched from the OFF to the ON position with a hasp and padlock applied.

The isolators were installed in around 2009 on a Benninghoven Asphalt Plant, they are manufactured by **Craig and Derricott models DR063 3EB or 6EB** in either 63Amp or 125Amp in 3 pole or 6 pole configurations. (please note the later model part number DR1256EB/RS is a revised design).

Craig and Derricott isolator

- Please ensure that if you have this model they are replaced at the earliest opportunity and isolation procedures are modified for the plant to be isolated at an alternative source, until they have been replaced.
- As part of your PUWER Assessment Please check all other isolators on the plant to ensure they cannot be locked in the on position.
- Remind all operatives for the need to follow LOTOTO when carrying out Isolations on plant and equipment.
