## INCIDENT ALERT

**ALERT STATUS:** High Potential  
**DATE ISSUED:** 09/06/2020 15:46:39  
**INCIDENT No:** 02563

**COVID 19 - Hand sanitiser ignition - injuring haulier and causing vehicle fire**

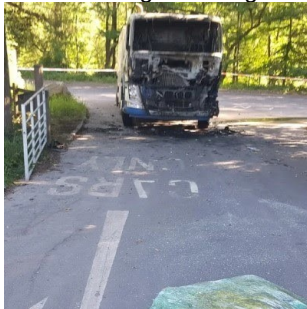
After opening the site gates, a haulier driver returned to his vehicle cab and used an alcohol-based hand sanitiser from a 1ltr container with pump and dispenser. After applying the hand sanitiser the haulier driver proceeded to light a naked flame which appears to have ignited the hand sanitiser residue on his hands, within the bottle and the cab. This caused an explosion and fire within the cab. The windscreen was blown out and thrown several metres down the road. The fire brigade extinguished the vehicle fire, and the haulier driver attended the local hospital where he was treated for burns to his hand and forearm.

- Alcohol based hand sanitiser is a flammable substance with a low flash point
- After application of hand sanitiser you should continue to rub your hands until dry, for at least 20 seconds before touching anything or continuing with your work (as advised by the Centre for Disease Control and prevention CDC)

- If you are working with electricity, in the proximity of an ignition source, conducting any hot work, or within a confined space you should use soap and water instead of hand sanitiser to wash your hands before and after the activity.

- Avoid leaving them within vehicles and on window sills Where there is a need to carry hand sanitiser on your person or within a confined space e.g. a vehicle, please do so in minimal quantities
