# Battery Acid Splash in Eye

## WHAT HAPPENED

**INCIDENT No:**

**00319**

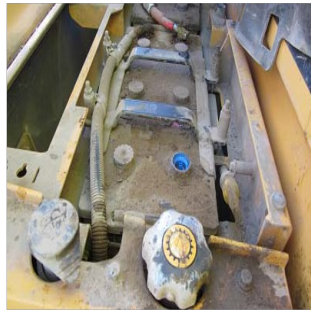
The Excavator operator then proceeded to unclip the jump leads from the excavators battery, as he did so a cap on the ADT battery “popped” off the battery and acid was ejected up into the air and into the face of the ADT operative splashing acid burns on his forehead and in his eyes.

ATD Battery with Cap Missing

ONLY COMPETENT, AUTHORISED PERSONS SHOULD CARRY OUT THIS TASK.

A RISK ASSESSMENT MUST BE COMPLETED PRIOR TO THE TASK COMMENCING.

ENSURE THAT INDIVIDUALS UNDERTAKING THE TASK ARE FAMILIAR WITH THE MANUFACTURERS AND COMPANY GUIDELINES ON JUMP STARTING THE PLANT
