# FATAL 1 - LOTOTO - Failure to follow correct isolation procedures - HiPo

A HiPo near miss occurred when interlocks were used as a form of isolation.

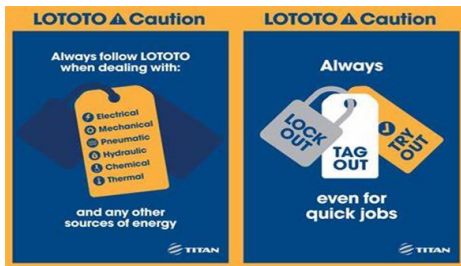
During aggregate processing, a blockage occurred within the chute under the secondary screen. To clear the blockage access to the area protected by distance guarding was required. The dedicated isolation point for the screen belt was not utilised, instead the interlock located on the access gate of the distance guard was relied on for the isolation, this was against the agreed SSW and training.

- Isolation procedures should always be followed and individual locks attached by anyone entering the area.
- Limit switches/interlocks must never be used as a form of isolation. These systems break the signals on a control circuit like an emergency stop button.
- Try out must always be conducted to ensure the equipment has been successfully isolated.
