## INCIDENT ALERT

**LOCATION:** LIME & SLAG PLANTS  
**ACTIVITY:** MAINTENANCE & HOUSEKEEPING  
**SUB ACTIVITY:** N/A

**ALERT STATUS:** Normal  
**DATE ISSUED:** 10/10/2013  
**INCIDENT No:** 00370

**Asbestos in Kiln Bearing Heat Shields / Covers**

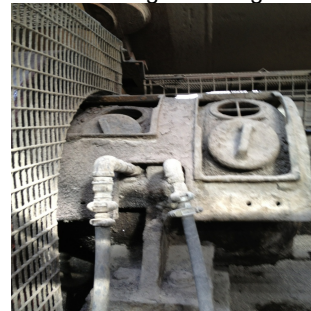
The Kiln is undergoing modification and as a consequence, a sample from one of the Kiln Bearing Heat Shields was submitted for testing. The results from this indicate the presence of Chrysotile asbestos.

The Kiln Bearing Heat Shields are the original F.L. Smidth covers that fit very closely to the kiln bearings. Although this type of asbestos represents a lower risk than other asbestos types, it should not be disturbed.

Advice has been taken and it is likely that this material will require removal by a specialist company and the various options are being considered.

- 1) All of the four beds on the kiln have been taped off, with signs stating that access should not be made. These areas will be further restricted by the erection of scaffold barriers.
- 2) The heat covers from number 5 tyre have been covered over with bags to contain any material. A scaffold protection frame will be installed over the weekend to protect these from being struck.
- 3) Site personnel and contractors have been informed

(Where heat resistant covers do not have to be removed, the company has been advised that access will be acceptable to replace the oil in a bearing for example).
