Fatal 3 - TRANSPORT - Employee driver falls exiting cab and injures leg

LOCATION: CEMENT PLANT
ACTIVITY: ACCESS & EGRESS & WORKING AT HEIGHT
SUB ACTIVITY: N/A

ALERT STATUS: Normal
DATE ISSUED: 20/03/2024 14:02:20
INCIDENT No: 03701

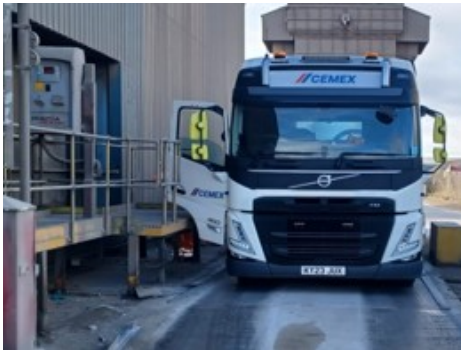
An employee cement tanker night driver loaded his vehicle and proceeded to the weighbridge. He stopped the vehicle too close to the weighbridge platform and, as a result, the cab door wouldn't open fully as the underside was catching on the platform.

Workplace layout - The cabs of the new fleet of Volvos are lower, to aid better vision of vulnerable road users, and therefore the doors were catching on the walkway platform.

Get a grip - Due to the cab door hitting the platform, the driver could not exit the vehicle backwards holding onto the grab handles and chose to step out forwards.

Safe system of work - Drivers were informed to position their vehicles slightly further away from the platform so the doors wouldn't catch and they could safely access / egress.

- Review processes to eliminate or reduce the need for drivers to leave their cabs; in this case the site is in a port and port security require the despatch ticket to be stamped with a pass in the weighbridge office.
- As previously instructed, the driver should have repositioned the vehicle when he realised he couldn't open the door fully, enabling him to get out backwards, using both grabrails, giving him 3 points of contact.
- Assess whether any modifications could have been carried out to the platform to overcome the restriction with the doors on the new vehicles.

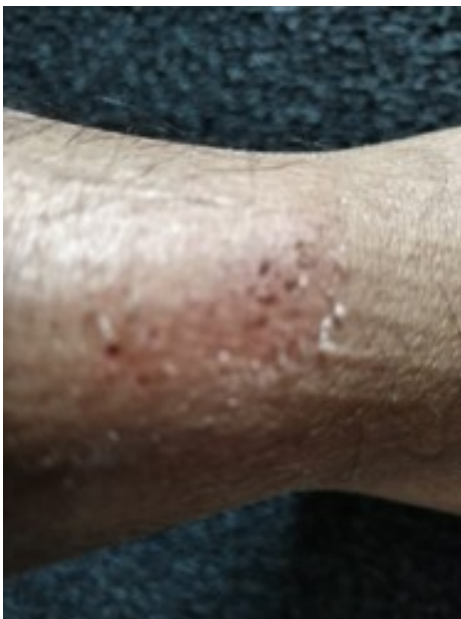
Rather than repositioning the vehicle, he attempted to exit the cab forwards and fell / slipped onto the gantry, causing a graze to his leg. The Driver continued with his night shift, not reporting the incident until he arrived at the customer's site. Unfortunately, the driver was absent from work as a result of his injury. The image shows the injury sustained.

Incident reporting - The driver should have reported the incident immediately to the Weighbridge or Night Shift Manager in accordance with the reporting protocol.
