Fatal 5 - Truckmixer water hose incident.

LOCATION:	READYMIX OR MORTAR PLANT	ALERT STATUS:	Normal
ACTIVITY:	TRANSPORT & LOGISTICS / DELIVERY	DATE ISSUED:	02/12/2024 18:00:13
SUB ACTIVITY:	DRIVER AWARENESS	INCIDENT No:	04850

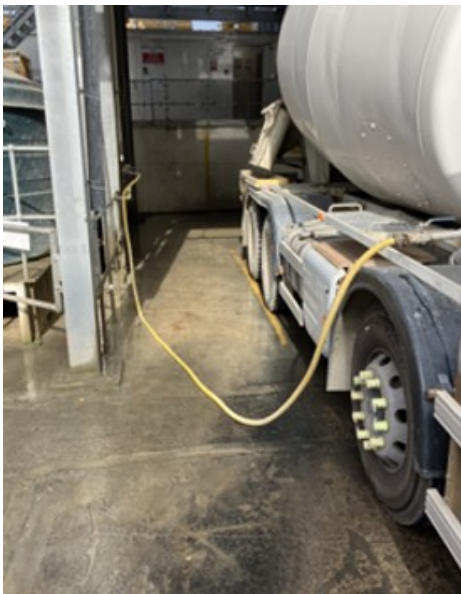
- Locate the pipework and hose on the drivers' side. Image below shows example of the preferred type of set-up.

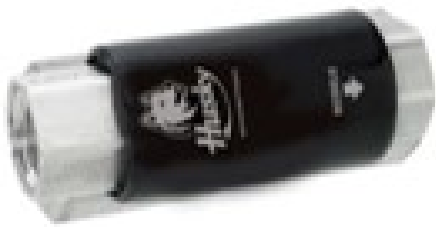
- Position the pipework such that the hose is as short as possible, ideally no longer than 5 metres.
- Fit magnetic couplings between the metal pipework and hose to act as a weak point and prevent a breakaway under force; the "T" piece to the pipework should be fitted in line with the direction of the hose coupling. See an example of a coupling below

Recommended magnetic coupling details:

- Re-usable magnetic coupling.
- Make / model: Husky #003385 Reconnectable Safe-T-Break
- Shock absorbing spring to stop nuisance breaks.
- Separates at under 200lbs to minimise backlash

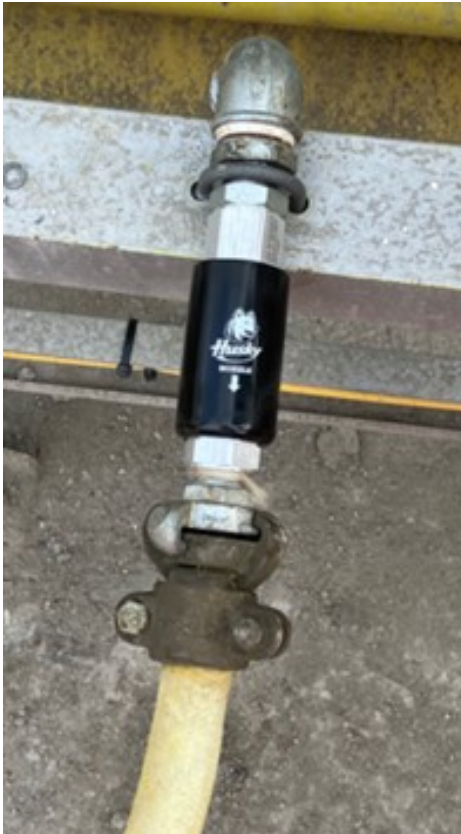
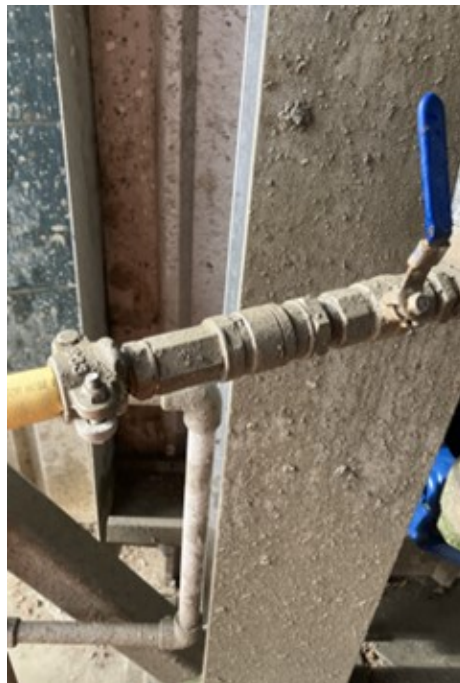
Image above shows a magnetic coupling in place and a typical example of a connection without one.
