**TRANSPORT - Fatal 2 - Adverse weather conditions - black ice - causes tipper to slide and strike staircase in stockyard, driver lucky to avoid serious injury - Video**

**LOCATION:** READYMIX OR MORTAR PLANT  
**ACTIVITY:** TRANSPORT & LOGISTICS / DELIVERY  
**SUB ACTIVITY:** DRIVER AWARENESS

**ALERT STATUS:** Normal  
**DATE ISSUED:** 28/01/2025 20:21:56  
**INCIDENT No:** 04857

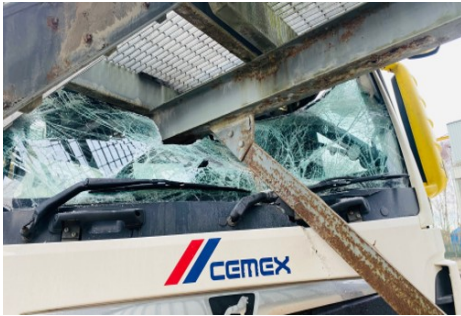
As the vehicle was entering onto the stocking area and making a left turn, it lost control on black ice, resulting in the vehicle impacting a staircase gantry.

- Evaluate the degree of risk associated with the icy conditions and, if required, limit access or shut down the site until it is deemed safe to proceed.
- In the aftermath of an incident, it is imperative to take prompt action to eliminate any hazards to prevent a recurrence.
- Site teams are advised to assess traffic routes to ensure that they are free from potential obstructions and that any vulnerable structures are adequately safeguarded with robust barriers or similar protective measures.
- Report and rectify identified issues associated with icy conditions promptly to prevent unsafe practices, ensuring that these issues are recorded in the near miss/hazard alert system.
- Stop, think and check it is safe, and always STEP IN if you see anything unsafe.

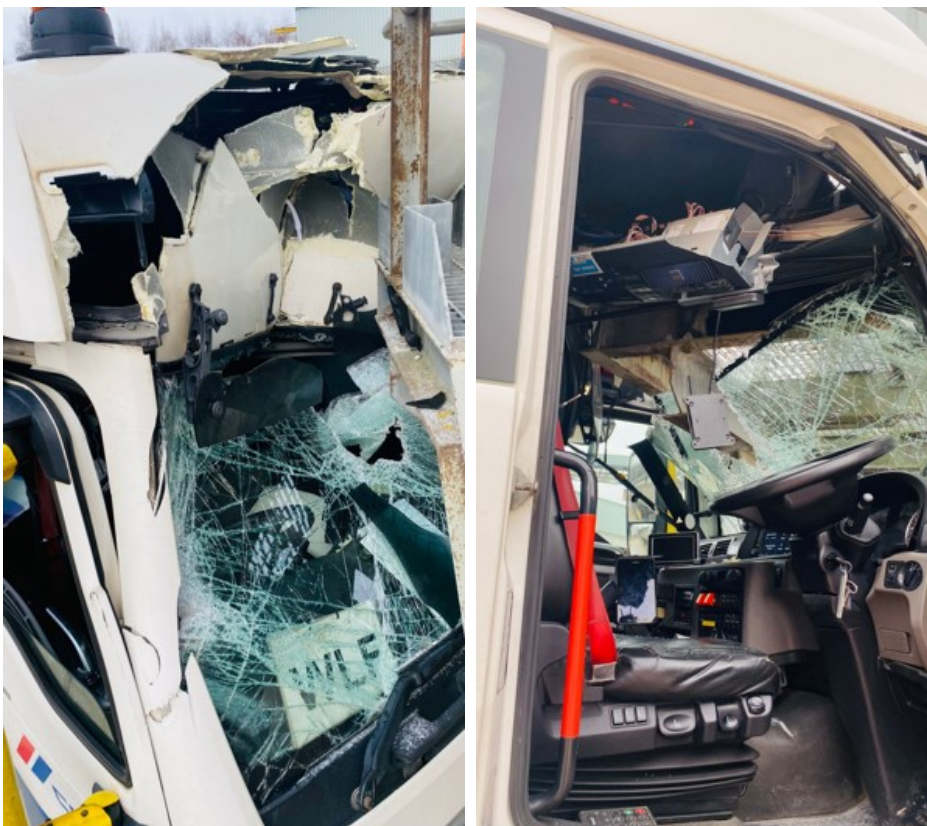
Fortunately, the driver was unharmed; however, the staircase penetrated the vehicle cab, which could have potentially caused serious injuries.

- This incident reinforces the importance of implementing thorough winter preparations to maintain the safety of traffic routes.
- The vehicle was fitted with all the required safety features.
- The vehicle experienced a loss of traction on the icy surface during a left turn, which caused the driver to lose control. The weight of the trailer pushed the unit into the gantry of the staircase.
- The vehicle was travelling at a speed of approximately 7 miles per hour
- The pedestrian routes had been gritted; however, the traffic routes had not been considered
- An earlier incident occurred on the site a few hours prior, involving a vehicle that lost control due to the icy conditions.
- The driver wasn't notified of the ice present in the stockyard
