TRANSPORT - Fatal 2 - Adverse weather conditions - black ice - causes tipper to slide and strike staircase in stockyard, driver lucky to avoid serious injury - Video

LOCATION:	READYMIX OR MORTAR PLANT	ALERT STATUS:	Normal
ACTIVITY:	TRANSPORT & LOGISTICS / DELIVERY	DATE ISSUED:	28/01/2025 20:21:56
SUB ACTIVITY:	DRIVER AWARENESS	INCIDENT No:	04857

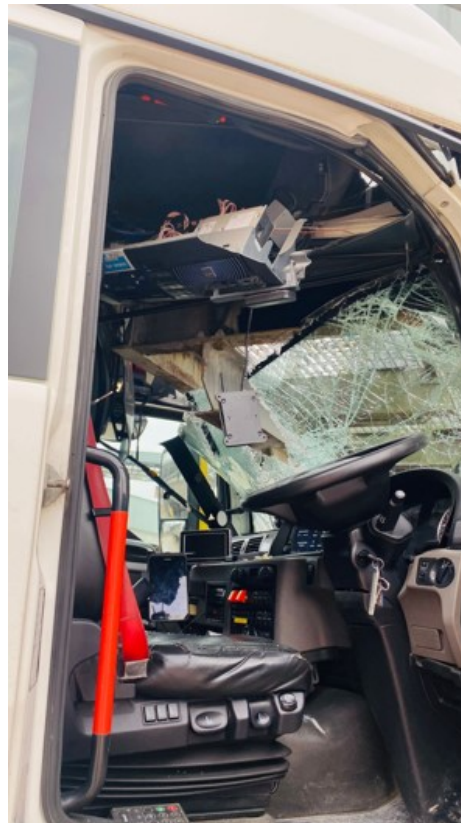
Fortunately, the driver was unharmed; however, the staircase penetrated the vehicle cab, which could have potentially caused serious injuries.

- This incident reinforces the importance of implementing thorough winter preparations to maintain the safety of traffic routes.
- The vehicle was fitted with all the required safety features.
- The vehicle experienced a loss of traction on the icy surface during a left turn, which caused the driver to lose control. The weight of the trailer pushed the unit into the gantry of the staircase.
- The vehicle was travelling at a speed of approximately 7 miles per hour
- The pedestrian routes had been gritted; however, the traffic routes had not been considered
- An earlier incident occurred on the site a few hours prior, involving a vehicle that lost control due to the icy conditions.
- The driver wasn't notified of the ice present in the stockyard

- Evaluate the degree of risk associated with the icy conditions and, if required, limit access or shut down the site until it is deemed safe to proceed.
- In the aftermath of an incident, it is imperative to take prompt action to eliminate any hazards to prevent a recurrence.
- Site teams are advised to assess traffic routes to ensure that they are free from potential obstructions and that any vulnerable structures are adequately safeguarded with robust barriers or similar protective measures.
- Report and rectify identified issues associated with icy conditions promptly to prevent unsafe practices, ensuring that these issues are recorded in the near miss/hazard alert system.
- Stop, think and check it is safe, and always STEP IN if you see anything unsafe.
