# Fatal 3 - During maintenance project at a cement plant serious structural fault in walkway discovered.

**LOCATION:** CEMENT PLANT  
**ACTIVITY:** MAINTENANCE & HOUSEKEEPING  
**SUB ACTIVITY:** WALKWAYS

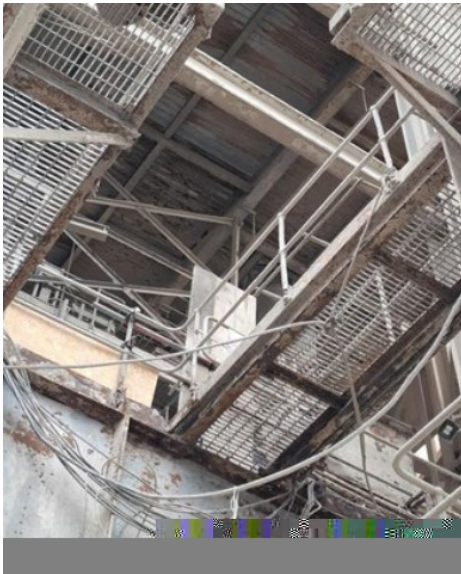
During a filter replacement project the cleaning of the bypass and surrounding area uncovered severe corrosion to support steelwork. One side of the supporting structure was corroded to a degree which could have resulted in a collapse of the walkway gantry.

- Ad hoc structural surveys ineffective for a complex cement site.
- Material spillages in contact with rainwater accelerate corrosion.
- Insufficient resources for proper housekeeping and cleaning activities.

- A detailed written scheme is being developed with the third-party structural engineers, ensuring all areas of the plant are inspected at the required frequency.
- Existing structures need to be deep cleaned, and a housekeeping planned maintenance check to be implemented.
