TRANSPORT - Fatal 5 - Driver exposes himself to risk of serious injury whilst inflating a tyre on a vehicle

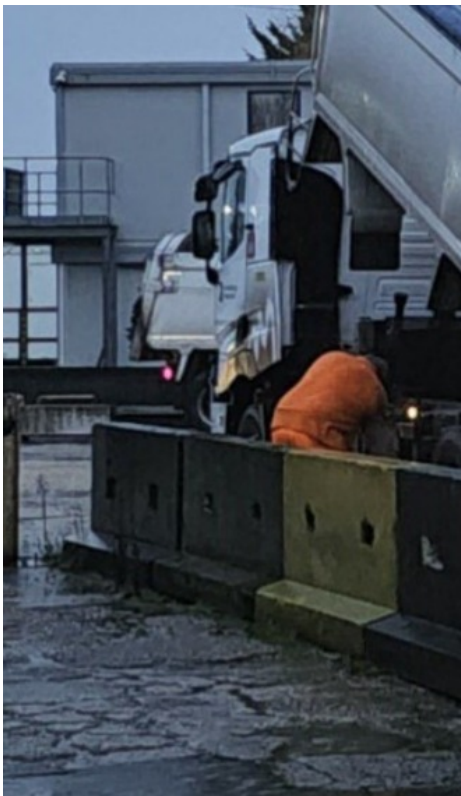
A franchise haulier's driver was seen underneath a raised tipper body with no body props, engine running, no RAMS or management approval, inflating a tyre with an airline that had no pressure gauge and without correct PPE. The driver's behaviour in failing to follow procedures had exposed himself to potential of sustaining a serious injury.

Note: The use of an airline with no inline pressure gauge could lead to over inflation and tyre explosion, a vehicle's typical tyre pressure is around 110psi, if exceeded, the tyre could explode. There are several incidents alerts on Safequarry where tyres have exploded whilst being inflated. Go to the [incident alert section of Safequarry](#) and add the word **tyre** to the **Keyword Search** to see examples.

- The PPE signs around the truck parking areas at the site would be improved.

- Tyre inflation and tyre defects are only to be carried out by trained/competent tyre fitter with RAMS/Management approval in place.
- Body Props are only to be used by trained/competent LGV fitters with RAMS/ Management approval in place.
- Consideration MUST always be taken to identify and control all forms of stored energy in all tasks to be completed (see list of types of stored energy below)
