TRANSPORT - Fatal 5 - Whilst attempting to tow a stuck mixer truck a chain snapped striking the vehicle.

LOCATION:	CONSTRUCTION/DELIVERY SITE	ALERT STATUS:	Normal
ACTIVITY:	TRANSPORT & LOGISTICS / DELIVERY	DATE ISSUED:	19/01/2026 20:04:45
SUB ACTIVITY:	DELIVERING READYMIX	INCIDENT No:	04967

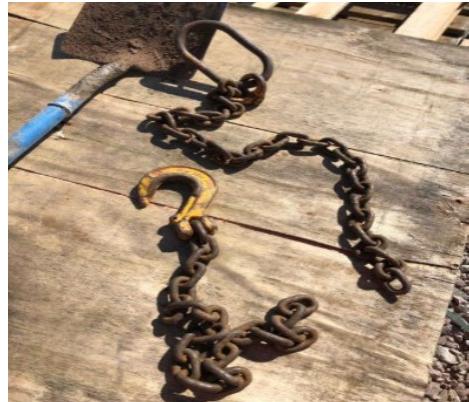
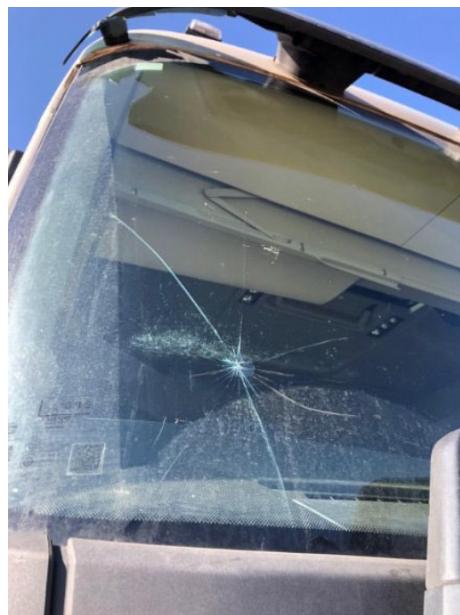
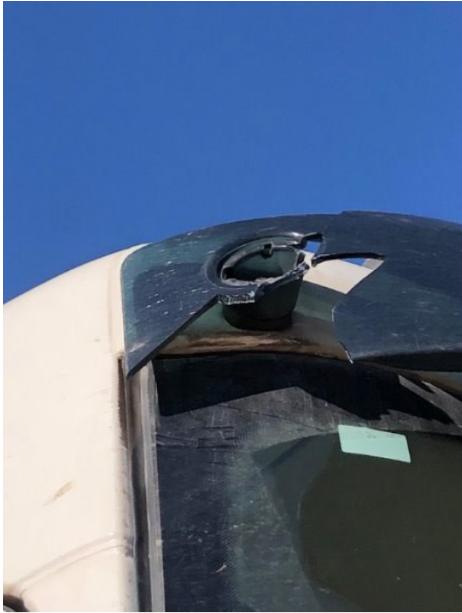
On the initial towing attempt, a single chain was utilised. Under tension, the chain failed and snapped, propelling a section of it through the air. The chain struck the mixer vehicle's windscreens directly in front of the driver's seated position. A subsequent attempt was made using multiple chains; however, one of these also failed under load.

As a result of these incidents, the mixer vehicle sustained damage to both the external sun visor and the windscreens. This incident could have resulted in an injury to an individual if they had been struck by the chain.

- No Risk Assessment carried out to determine hazards and controls.
- No procedure in place for the self-recovery of the vehicle.
- Lack of information, instruction and training provided to the driver.
- Incorrect equipment used to recover the vehicle.

The images below show the broken chain and the damage to the vehicle.

- Towing of stranded vehicles shall only be carried out by competent persons following a robust Risk Assessment & Method Statement using only approved equipment. Chains or ropes must never be used for towing.
- Working group to create a safe self-recovery procedure.
- Driver onboarding schedule updated to include towing restrictions along with annual refresher training and driver pack.
- Safety tags added to towing eyes to prompt management contact and requirement for a Risk Assessment prior to use.
