BEST PRACTICE

LOCATION: Asphalt/Coating plant ARTICLE YEAR: 2021
ACTIVITY: Maintenance & Housekeeping COMPANY: FM Conway
SUB ACTIVITY: N/A COMPANY LOCATION: Heathrow Asphalt Plant
BEST PRACTICE No: BP2088 COMPANY TEL: 0000
COUNTRY OF ORIGIN:

Asphalt drum hydro blasting

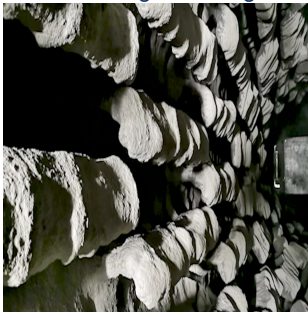
At FM Conway's asphalt plant at Heathrow, it was necessary to regularly remove the build-up of material sticking to the dryer finger lifters in the RAP drum. These fingers lift the material and drop it in front of the heat screen to allow the product to be heated and mixed correctly. Over time, the RAP drum clogged with old material blocking the finger lifters and cooled material stuck to the drum. This causes the plant to run less efficiently and results in more wear and tear on the components due to the increased weight of this material.

Before

FM Conway developed a new system using pressure jets to achieve this.
