## BEST PRACTICE

LOCATION:	Quarry	ARTICLE YEAR	2006
ACTIVITY:	Manual handling and storage	COMPANY:	Bardon Aggregates
SUB ACTIVITY:	N/A	COMPANY LOCATION:	Manor Farm Quarry, Gloucestershire
BEST PRACTICE No:	BP302	COMPANY TEL:	01285 810926
COUNTRY OF ORIGIN:	United Kingdom

<b>Automated weighbridge cleaning</b>	
ARTICLE	
<p>Cleaning beneath the low-level weighbridge with a hosepipe used to be a difficult and time-consuming task, requiring high levels of manual handling.</p> <p>The quarry manager has now found a more effective method. A two inch galvanised steel pipe has been attached alongside the weighbridge complete with several taps which release a fine spray underneath the bridge.</p> <p>For just £500, the new system has reduced manual handling and the risk of slips, trips and falls. The manufacturers of the weighbridge consider it to be good practice, as it maintains accuracy of the bridge for longer and makes it easier to maintain.</p>	
ARTICLE IMAGES	
<p data-bbox="667 833 895 862" style="text-align: center;">Click image to enlarge</p> <div data-bbox="625 862 935 1169" style="text-align: center;">

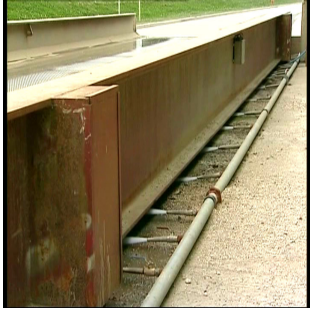
</div> <p data-bbox="603 1171 963 1200" style="text-align: center;"><b>Automated weighbridge cleaning</b></p>
